ROAD AND TRAIL ASSESSMENT SARATOGA QUARRY

Santa Clara County, CA

August 15, 2013

Job: DCE-QUARRYPARK-619

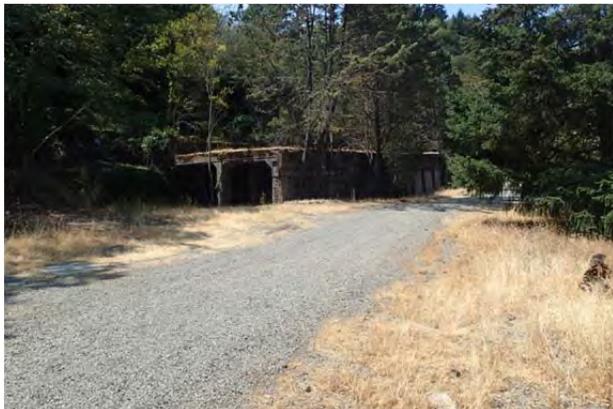
Condition and constraints: Overall Reach 1A is in good condition with no significant constraints for future use.

Photo 1: Reach 1A showing good surface condition. Old gravel loading structure in the background

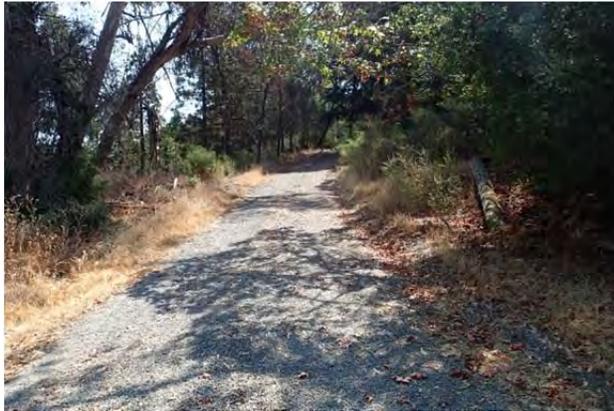
Photo 2: Grade of 17%. Road tread in good condition.

Condition and constraints: Overall, the road is in good to fair condition with no significant constraints. As previously mentioned, the steep 17% grade could impact drainage. Drainage will need to be upgraded by maintaining the inboard ditch and cleaning the storm drain inlet at the bottom of the reach. Depending on use the road surface may need to be periodically resurfaced. The fill embankment located at the wide segment of road appears loose and is probably prone to failure but presently does not impact the gravel segment of road.

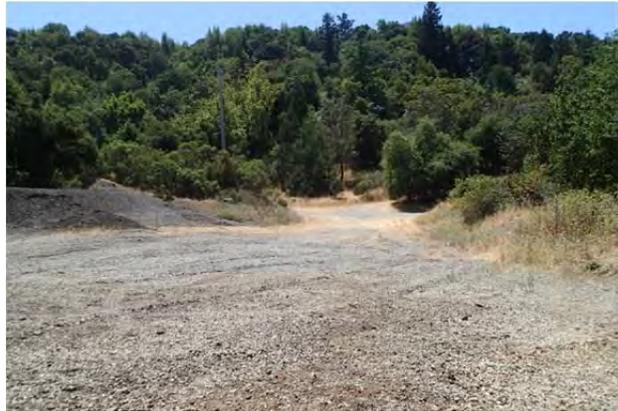
Photo 3: Large graded pad at P5.

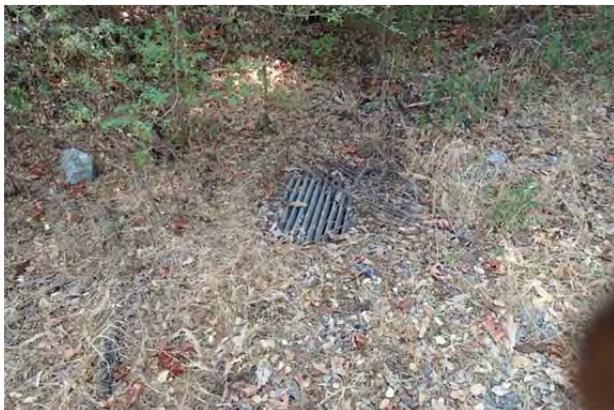
The steep 17% grade makes it difficult to drain the road and as a result runoff is conveyed down the road to the inlet of a storm drain (C2) near the bottom of the reach (Photo 4). The inlet to the storm drain appears partially plugged. Though drainage is only fair, there is no evidence of significant erosion of the road surface.

Photo 4: Inlet to storm drain at C2 appears partially plugged.

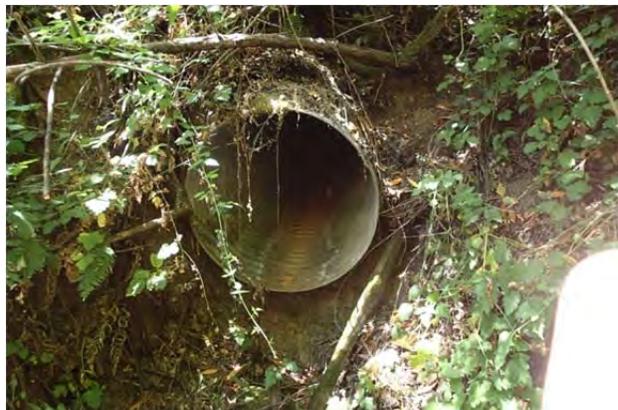
Photo 5: Outlet to 30-inch diameter CMP.

C2: 30" culvert: At the top of the reach is the outlet to a 30" diameter CMP that appears to extend to the pond (Photo 5). The culvert outlet appears in good condition. Presently there is no flow through the pipe suggesting the culvert inlet is blocked. The culvert inlet was not located. The pipe discharges into a dry ephemeral watercourse. The condition of the culvert and its association with the pond requires further review.

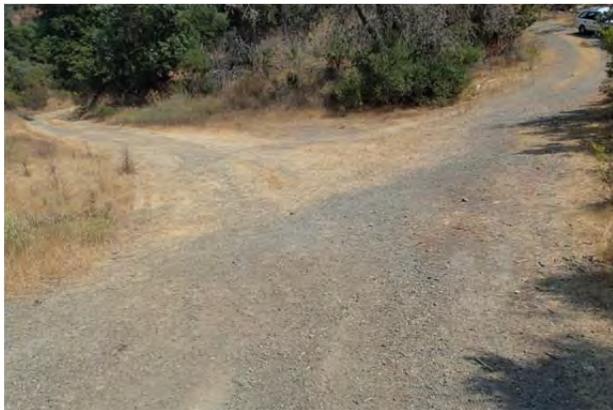
Photo 6: Photo of western portion of Reach 1C.

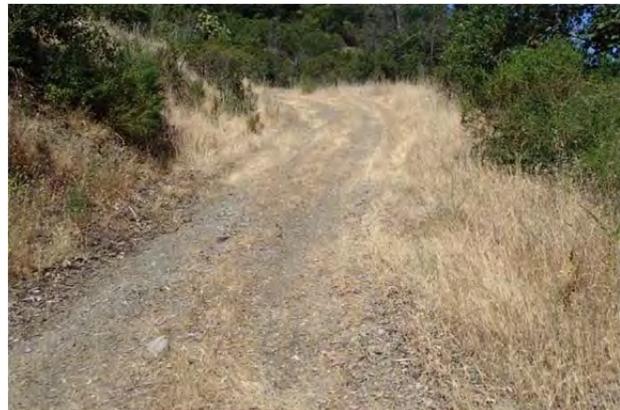
Photo 7: Minor rilling on steeper 20% road segment.

The majority of the road has a grade less than 15% with a couple of steeper segments. The last 250 feet of road climb at a steep 20+% grade (Photo 7).

The tread is lightly rocked though locally worn from use. A 40-foot segment of roadway at N3 has been undercut by stream bank erosion at the western end of the reach. Minor rilling is evident on the steeper road segments where the road grade exceeds 15%.

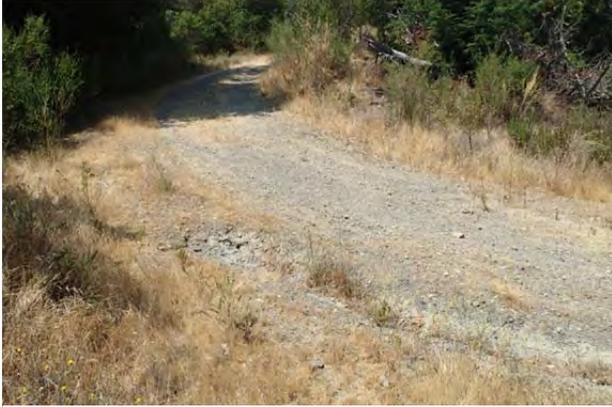
Reach 1D is a 200-foot segment of rocked road making the first loop with Road 1C. The road is lightly rocked at up to 20% grade. The steeper road segment appears rilled possibly from drainage coming off of Road 4 (Photo 8).

Photo 8: Steep rilled segment of Reach 1D.

Condition and constraints: Overall the road is in fair to good condition and suitable for continued use with upgrades. The steep 20% grade has a higher potential for erosion and therefore may require periodic maintenance. Drainage coming off of Road 4 will need to be upgraded if this segment is to be reopened.

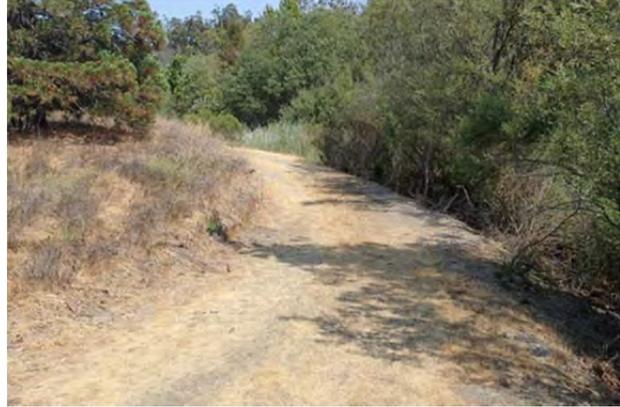
Photo 9: Well-vegetated edge of Reach 1E adjacent to pond.

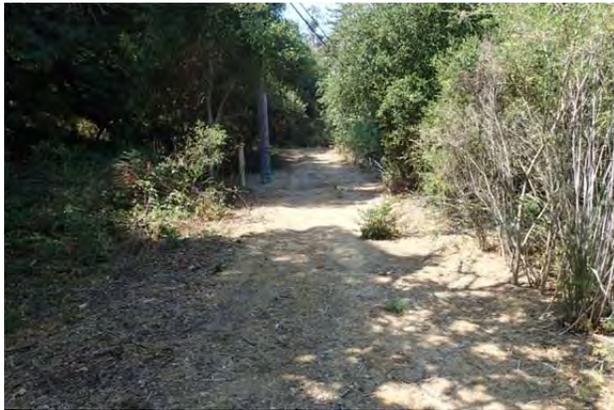
The road is lightly rocked and in fair condition, being somewhat rutted from use. Drainage is fair. There are no cross drains in place, though little significant erosion was observed. There is one culverted stream crossing at C4.

Photo 10: Lowered rutted segment of Road 2

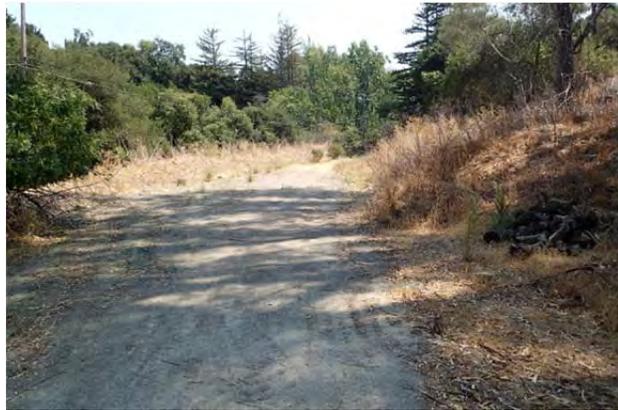
At the western end of the road before its intersection with the main gravel road is a broad graded pad (Photo 11). This pad appears to have been used to stockpile spoils, which partially block the road and form a large outside berm to the road.

Photo 11: Upper wide portion of Road 2. Large berm visible on left

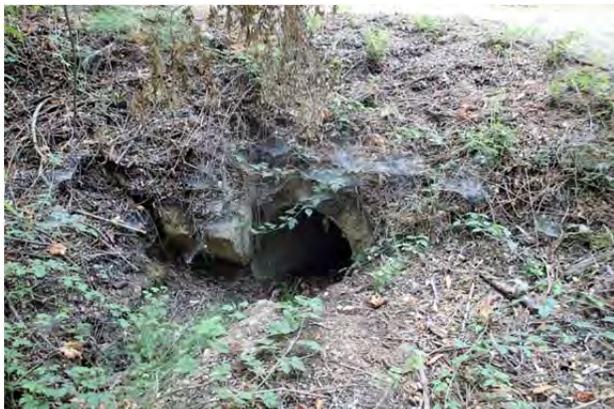
Photo 12: Inlet to rusted 36" culvert

C4: 36" culvert: This is a 36" x 30" diameter CMP draining a small intermittent to perennial stream near its confluence with Saratoga Creek (Photo 13). The culvert is rusted with pin holes

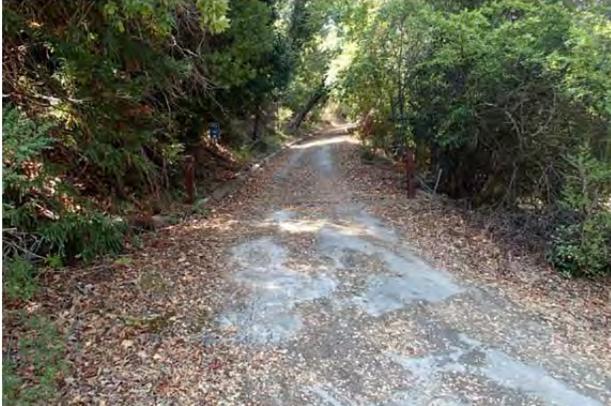
Road 3 is a 250-foot-long paved road accessing picnic grounds. The road is moderately steep at 16%-plus grade (Photo 13). Road is paved with the tread in good condition and drained by inslope to partially plugged storm drain inlet that will need to be cleaned. There are two old road failures at N17 and N18.

Photo 13: Photo of Road 3

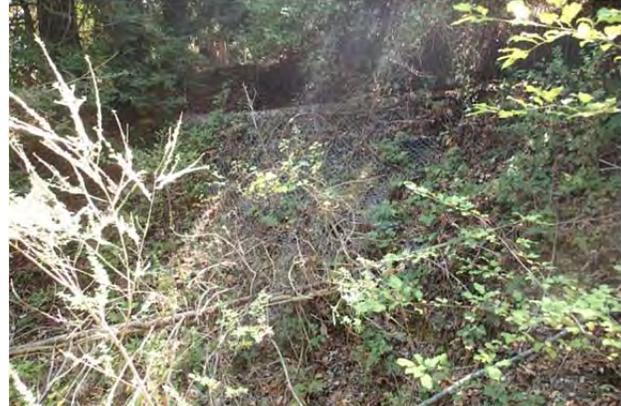
Photo 14: Cutbank failure at N17 above Road 3

N17: Old cutbank failure: This is an old 20-foot-wide cutbank/fillslope failure above the road. Slide appears to have been partially stabilized with an unengineered “chain-link fence” retaining wall (Photo 14).

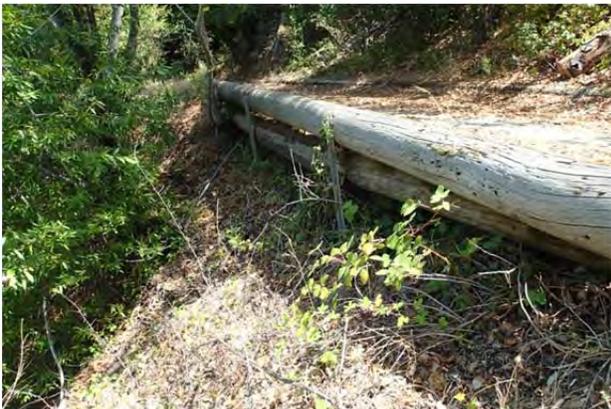
Photo 15: Crib wall at fill failure N18 on Road 3

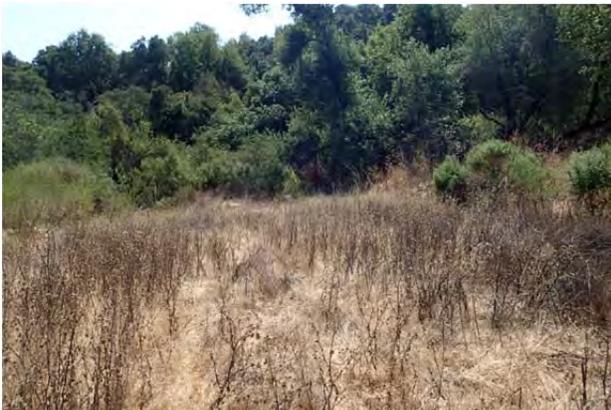
The road is routed up a graded bench at 15% grade. Much of the tread is grassed over with the lower (northern) portion indistinct (Photo 15). There is no evidence of any drainage dips installed. There is little evidence of erosion, mainly because the road is grassed over.

Photo 15: Looking up overgrown road 4

Condition and constraints: Overall the road is in good to fair condition and is suitable for future use with drainage upgrades. Culvert inlets should be cleared. If the road is reopened then drainage on the lower road segment will need to be improved to avoid draining onto Road 1D.

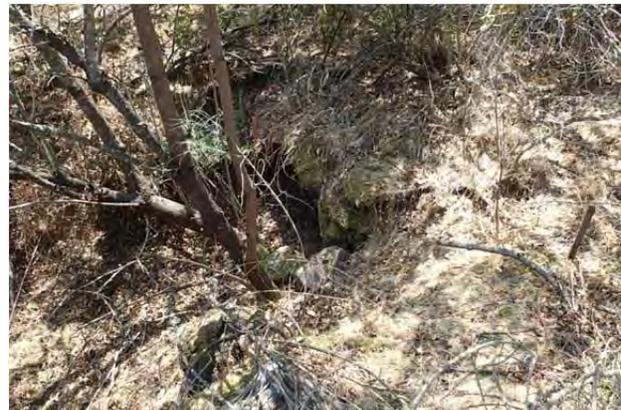
Photo 16: Inlet to culvert C5

C5: 30" Culvert: 30" x 20' CMP draining small ephemeral watercourse with very little flow (Photo 16). Culvert is intact without problems.

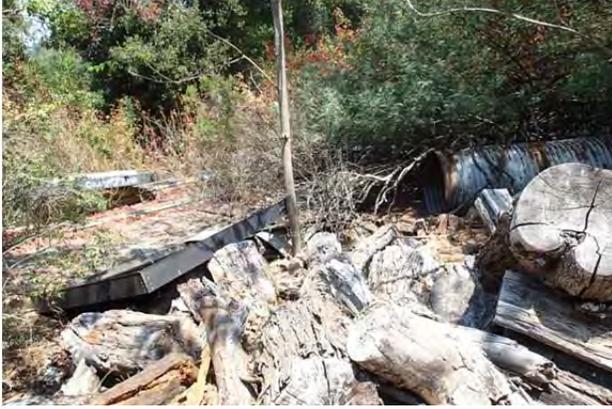
Photo 17: Debris on lower pad

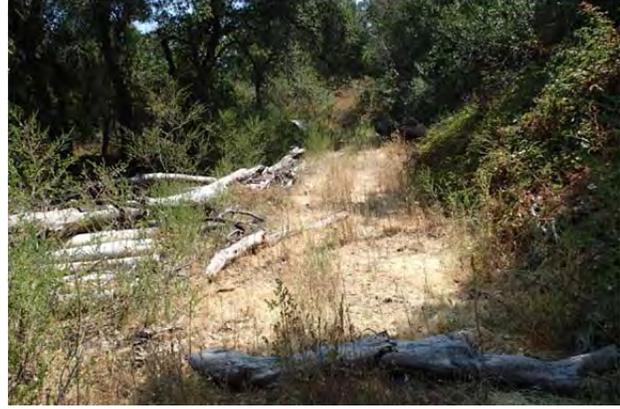
Photo 18: End of road 4

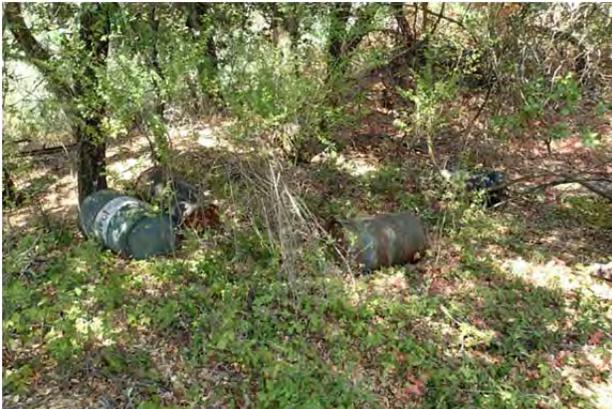
Road 4 is a 350-foot-long, infrequently-used, unsurfaced and grassed-over road accessing two graded pads (P6 and P7). These pads are stockpiled with old construction material, culverts, pipes, and other debris (Photos 17 and 18). There is one culverted watercourse crossing at C4 and a small diameter ditch relief culvert at C5. Several oil drums are found at the end of the road (Photo 19)

Photo 19: Oil drums on Road 4

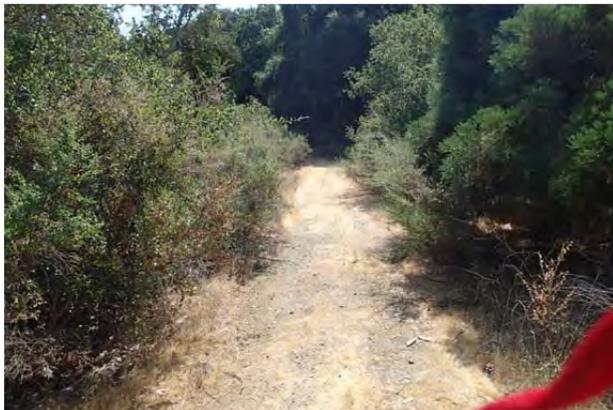
The lower 400 feet of road climbs at a 15% to 18% grade (Photos 20 and 21); thereafter the grade drops to a more favorable grade of less than 5% (Photo 25).

Photo 20: Lower portion of Road 5

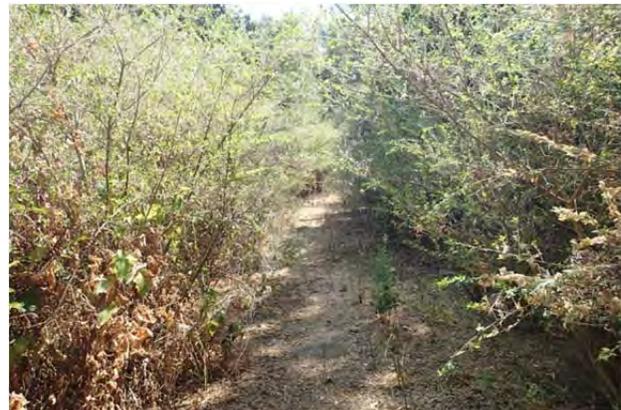
Photo 21: Middle portion of Road 5

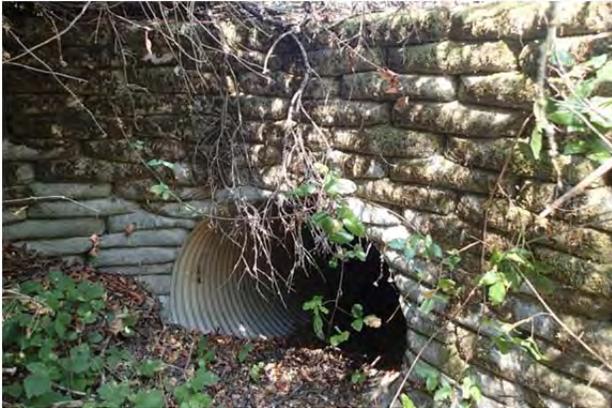
Photo 22: Inlet to culvert C7

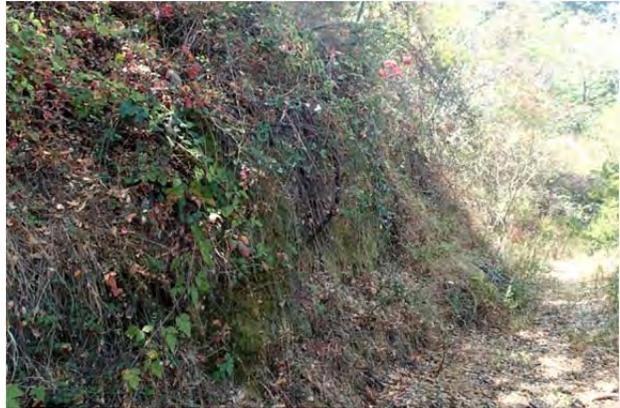
There are two functional watercourse crossings along the alignment (C7 and C8). A short retaining wall supports a 45-foot-long segment of road cut at N4. At N5 there is a small sinkhole in the road bed.

Photo 23: Possible old concrete retaining wall at N4

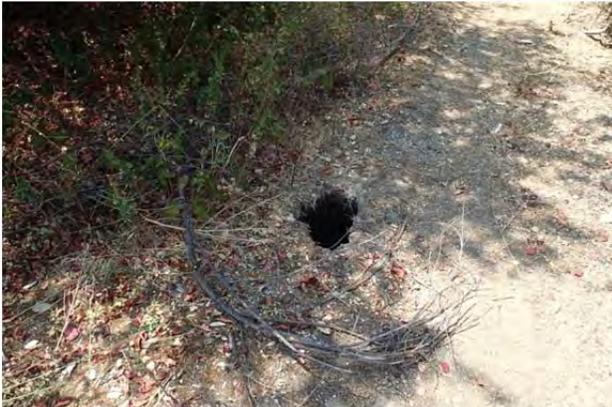
Photo 24: Small sinkhole at N5

Condition and constraints: Overall the road is in good to fair condition and suitable for continued use with upgrades. The principal constraint is the moderately steep 18% grade in the initial section of road. For future use, road drainage will need to be upgraded by installing drainage dips. The sinkhole at N5 will need to be excavated and reconstructed.

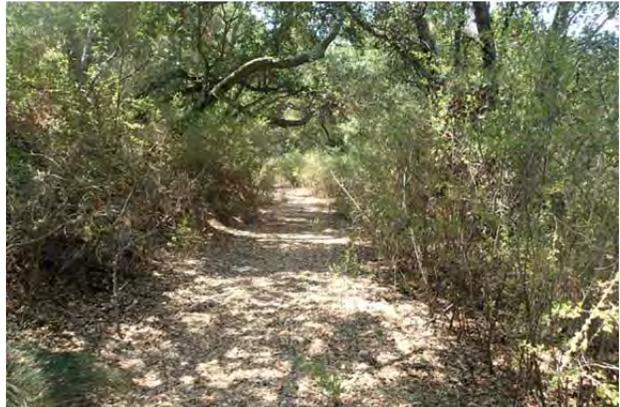
Photo 25: Upper portion of Road 4

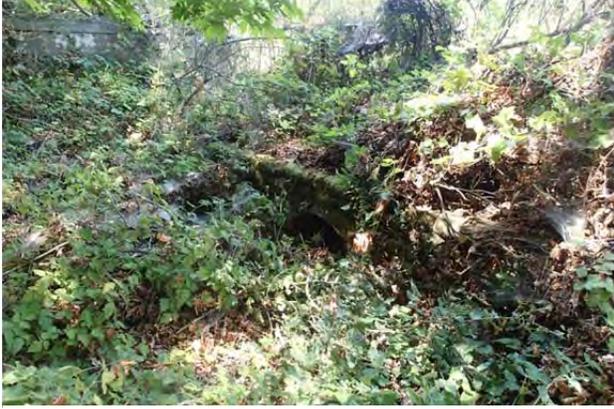
Photo 26: Inlet to culvert C8. Concrete water tank to left.

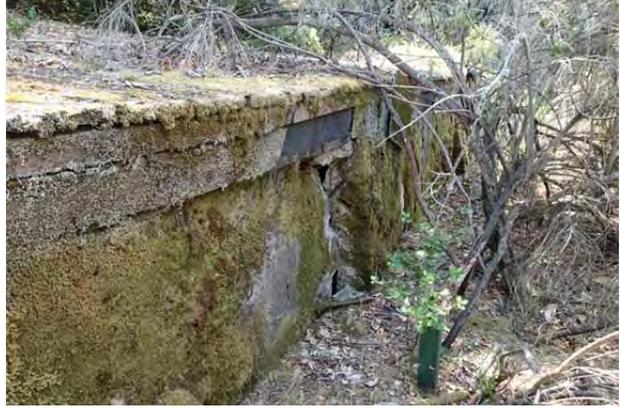
N6: Concrete water tank: This is a 40-foot-long by ~22-foot-wide concrete water tank/reservoir located on the outer road edge (Photo 27). The water tank appears dry.

Photo 27: Concrete water tank N6

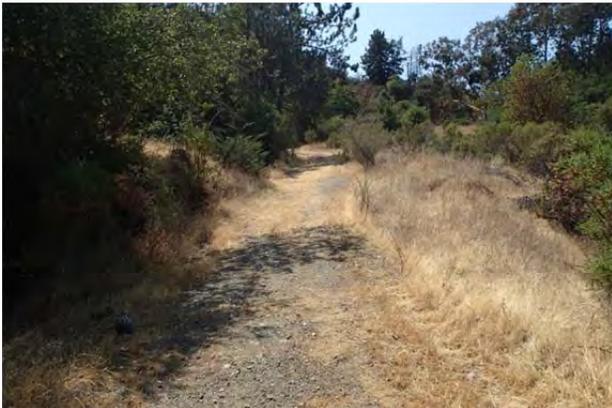
Photo 28: Looking up Road 6

Condition and constraints: Overall the trail is in good to fair condition and suitable for continued use with upgrades. The principal constraints are the steep 25% fall-line grade and the steps. Rerouting the trail to have a lower grade would be preferential, though may not be feasible due to topographic constraints in the area.

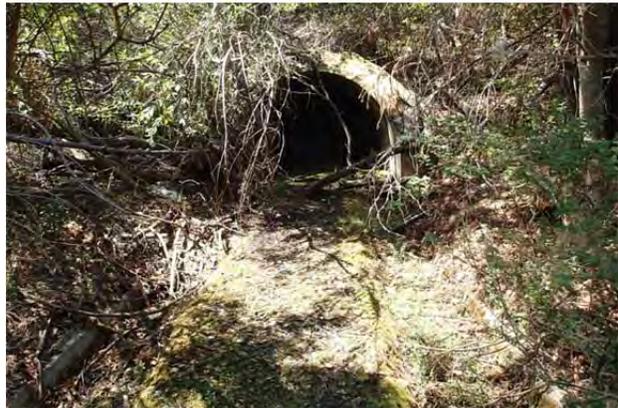
Photo 29: Entrance to Adit A1

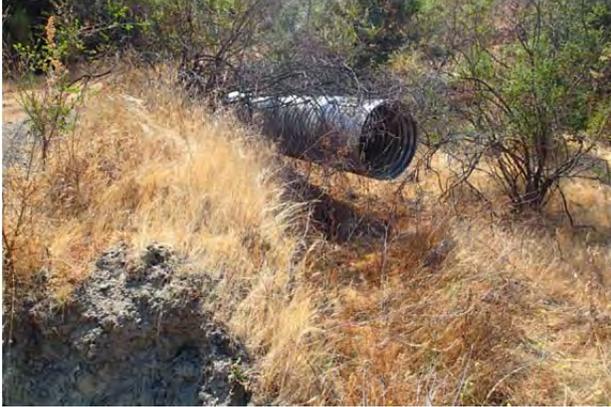
C9: 24" culvert: 24" x 40' long CMP draining inboard ditch (Photo 30). The ditch is infilled and flow bypasses the culvert.

Photo 30: Culvert C9 on Road 6

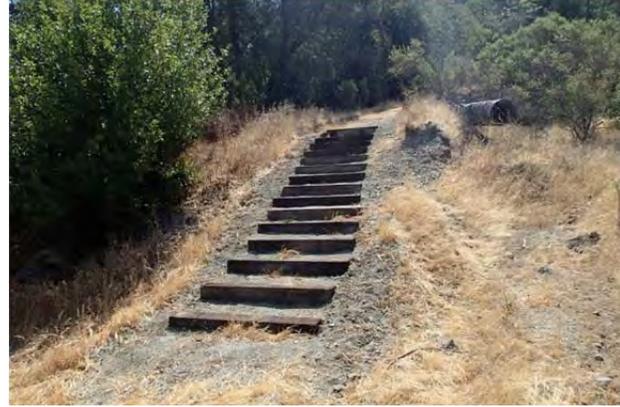
N7: Wood Steps: This is a series of recently installed wood steps constructed from railroad ties and anchored into the slope with rebar (Photo 31).

Photo 31: Recently built steps at the bottom of Road 6

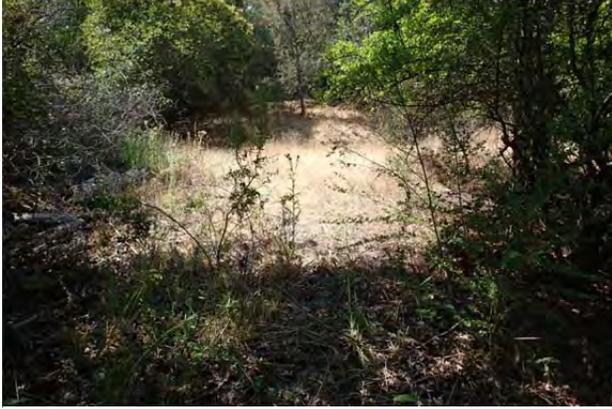
The trail grade is 10% with a short 25% section at the north end. The tread is unsurfaced and grassed over. The lower portion of the trail may be seasonally wet due to runoff coming out of adit A1 and flowing down to the site.

Photo 32: Lower portion of Road 6A

Condition and constraints: Overall, the trail is in fair condition with the principal issue being the steep grade and wet ground near the end. It should be feasible to regrade the lower portion of the trail and apply base rock to remedy this problem. This alignment would provide a lower grade alternative to using the stairs at Road 6.

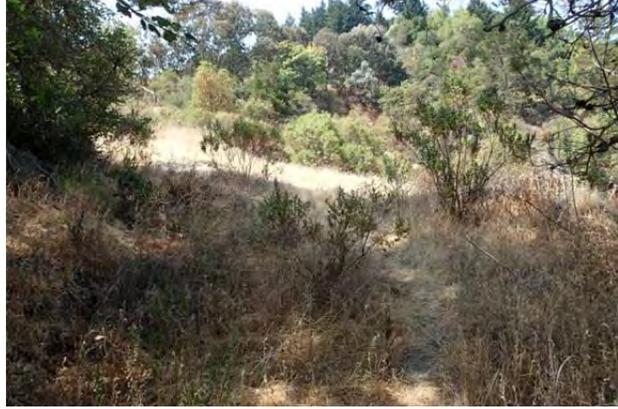
Photo 33: Western end of Road 6A

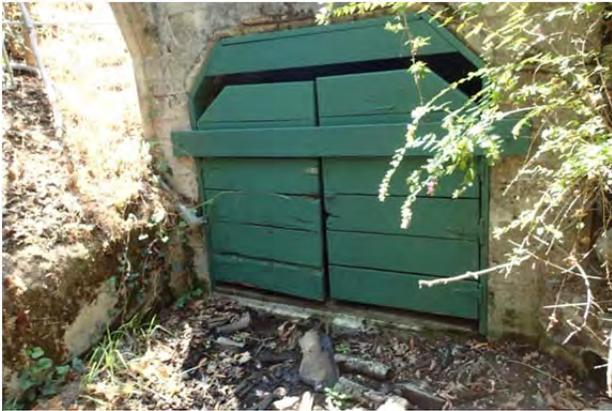
Photo 34: Entrance to Adit A2

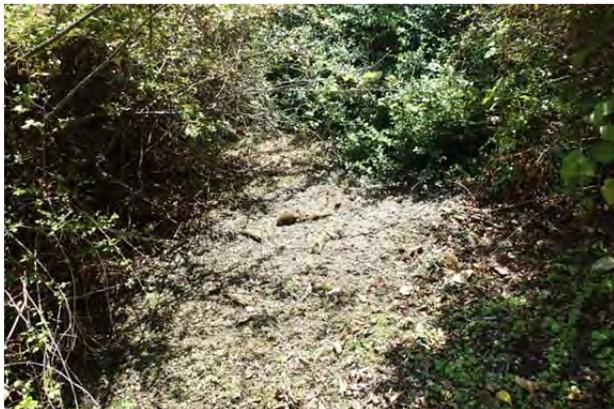
Photo 35: Wet ford crossing at C10

Condition and constraints: Overall the road is in good condition except for being overgrown. The road could easily be reopened for permanent use by clearing brush and installing drainage dips. Crossing C10 would need to be upgraded by installing a culvert, rock ford, or puncheon.

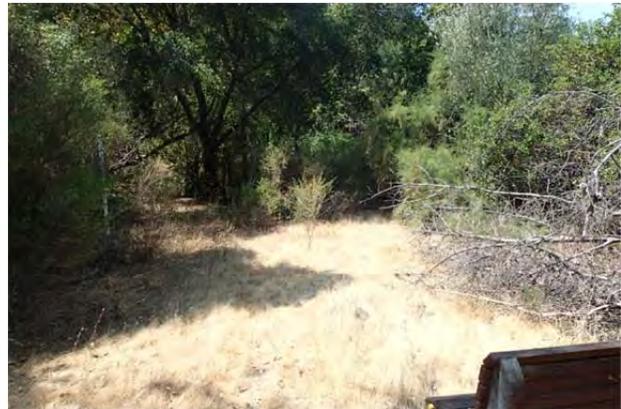
Photo 36: Wide bench on Road 7

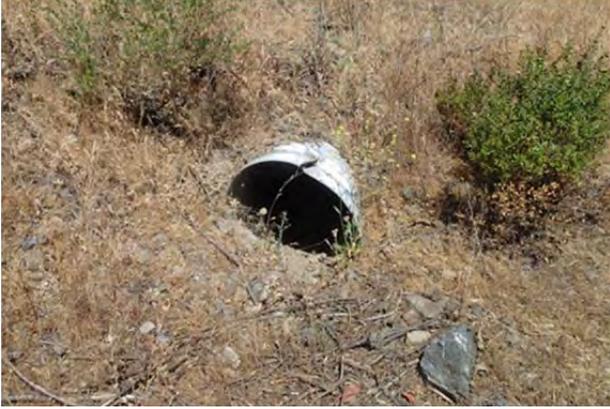
Photo 37: Inlet to culvert C12

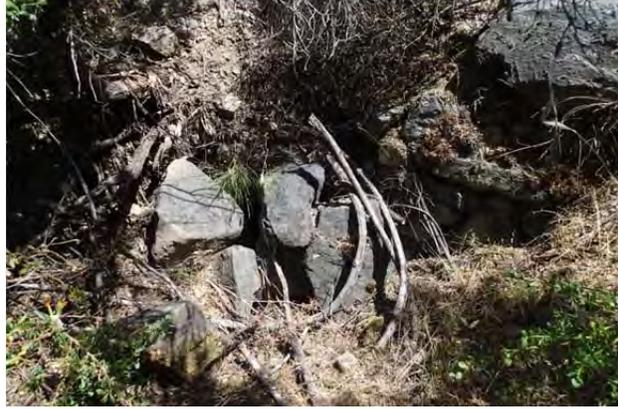
Photo 38: Partially blocked inlet to culvert C14

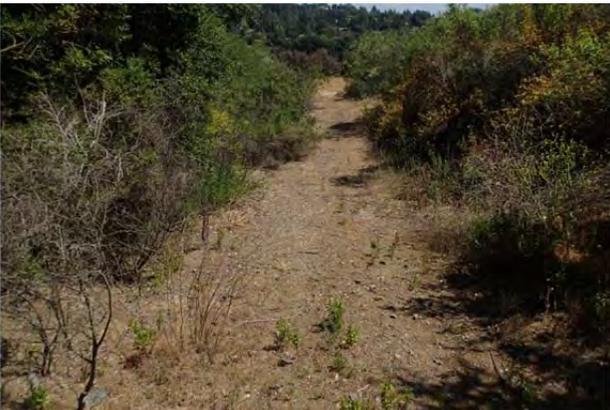
Photo 39: Looking down Road 8A

Condition and constraints: Overall this segment of trail is in good condition though drainage should be improved by installing a couple of drainage dips.

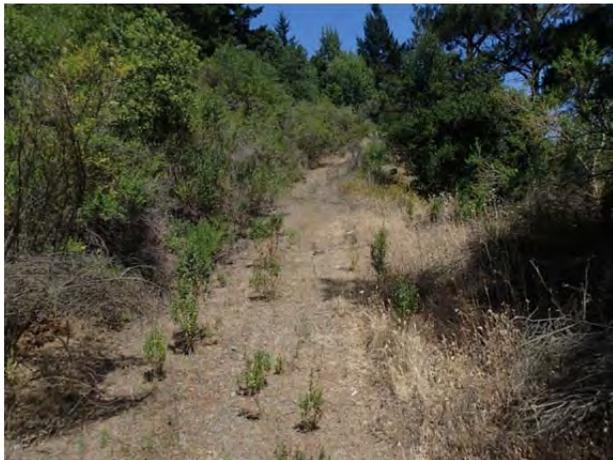
Photo 40: Lower portion of Road 8B

The road can be opened for trail use with the understanding that the steep grade will require a high level of maintenance to ensure that drainage dips are functional and to repair degraded segments. It may be possible to reduce the erosion potential narrowing the trail to a 4- to 5-foot width to reduce the amount of ground where runoff can occur. This may be accomplished by pulling back some of the perched fill along the outer edge of road and compacting the material along the inboard edge. Rerouting the trail to have a lower gradient is also a possibility but likely difficult due to the steep surrounding slopes.

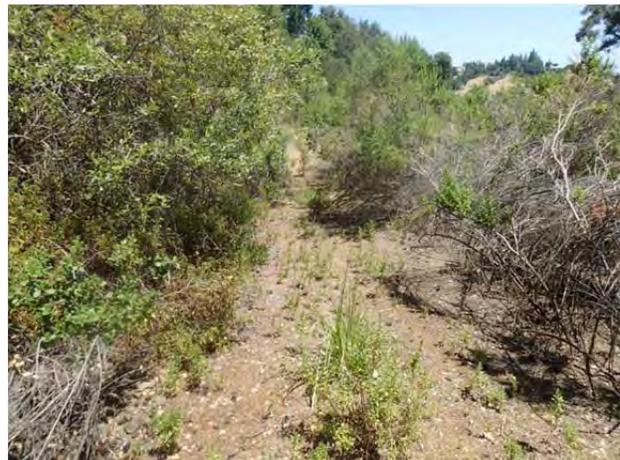
Photo 41: Middle portion of Road 8B before it becomes heavily vegetated.

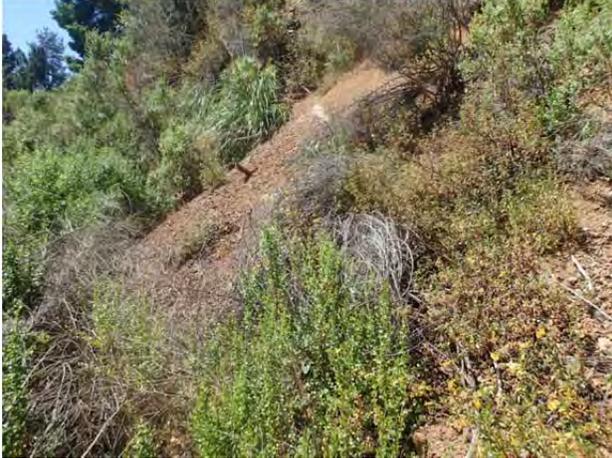
Photo 41: Cutbank instability on Road 8B

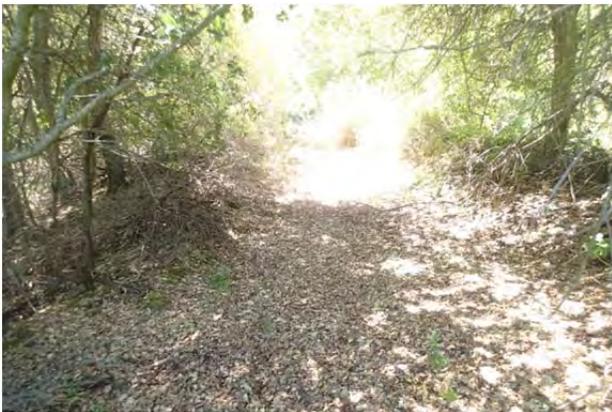
Photo 42: Steep fall line segment on Road 8C

It may be possible to reroute this trail to have a lower grade and to avoid a fall-line orientation.

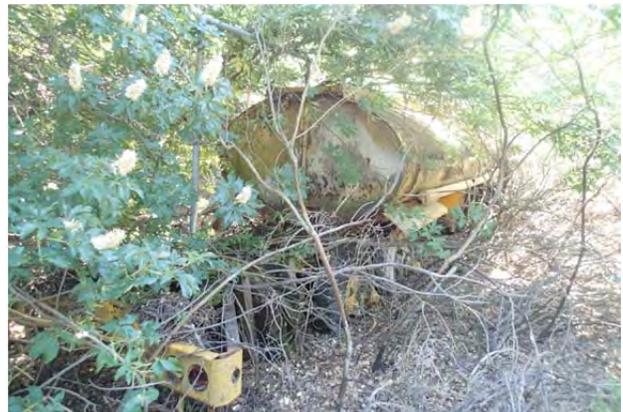
Photo 43: Old water truck at end of Road 8C
