*Arborist Report for Palm Villas Saratoga Project:  
January 29, 2016*

## ARBORIST REPORT

Tree Inventory, Tree Descriptions and Recommendations Relative to Proposed Construction

### Palm Villas, Saratoga (Lots 1 & 2)

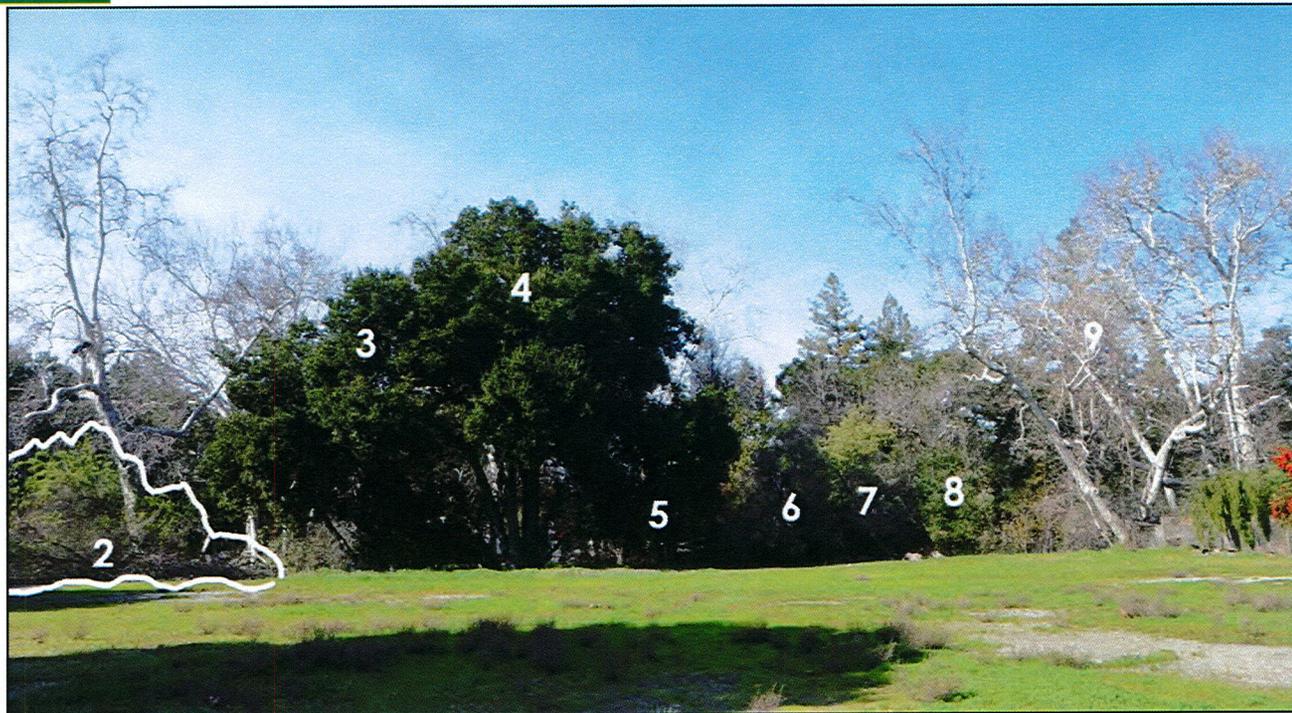
West perimeter of the site and northwest corner, Lot 1. From left to right: fallen and mostly dead **elderberry #2**, **coast live oak #3** and **4**, **elderberries #5, 6 and 7**, **coast live oak #8**, and **California sycamore #9**.

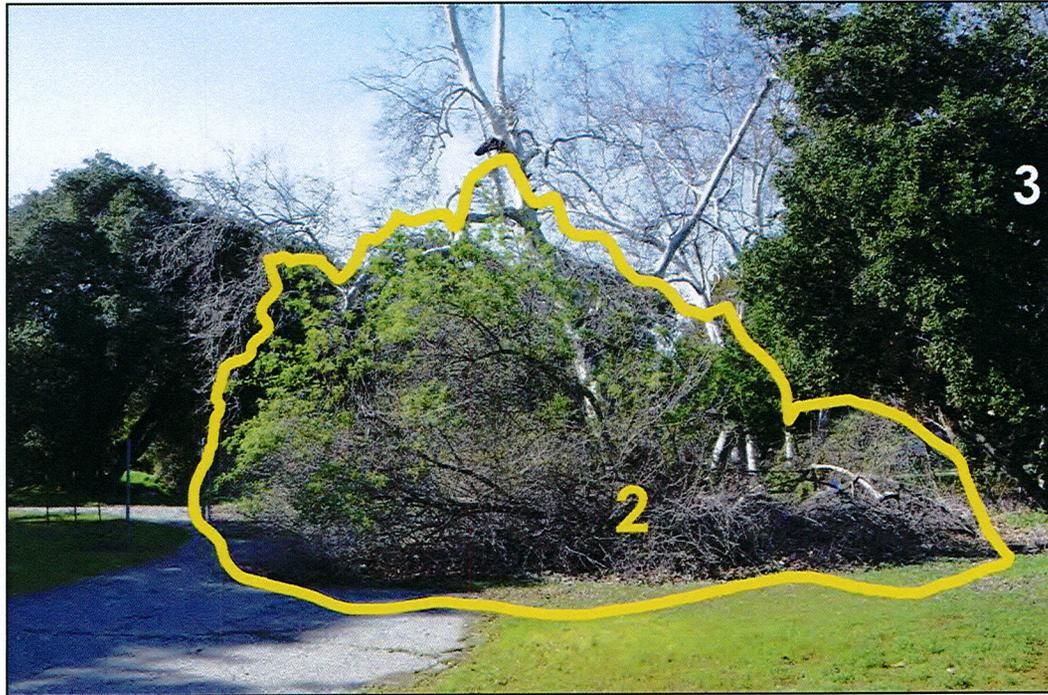
**Elderberry #2**, which probably does at least sprawl over a portion of the project site at the southwest corner.

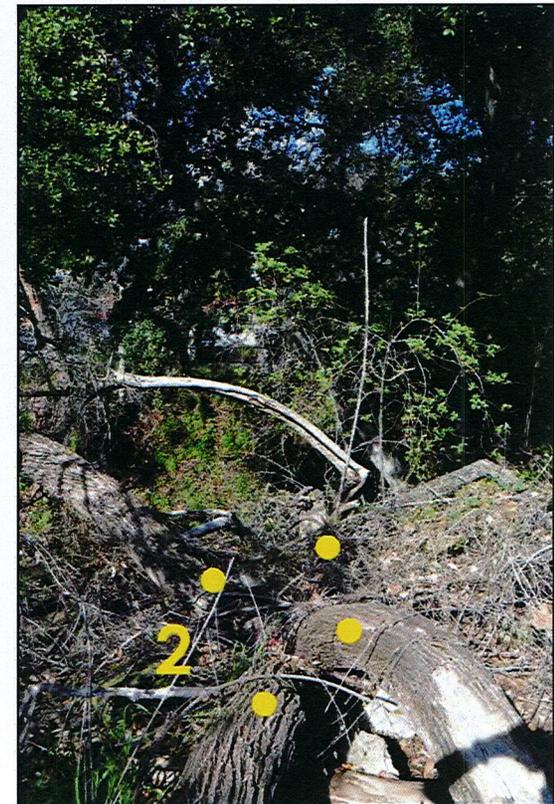
Close-up of fallen trunks of **elderberry #2**. I have placed a yellow dot near the base of each trunk.

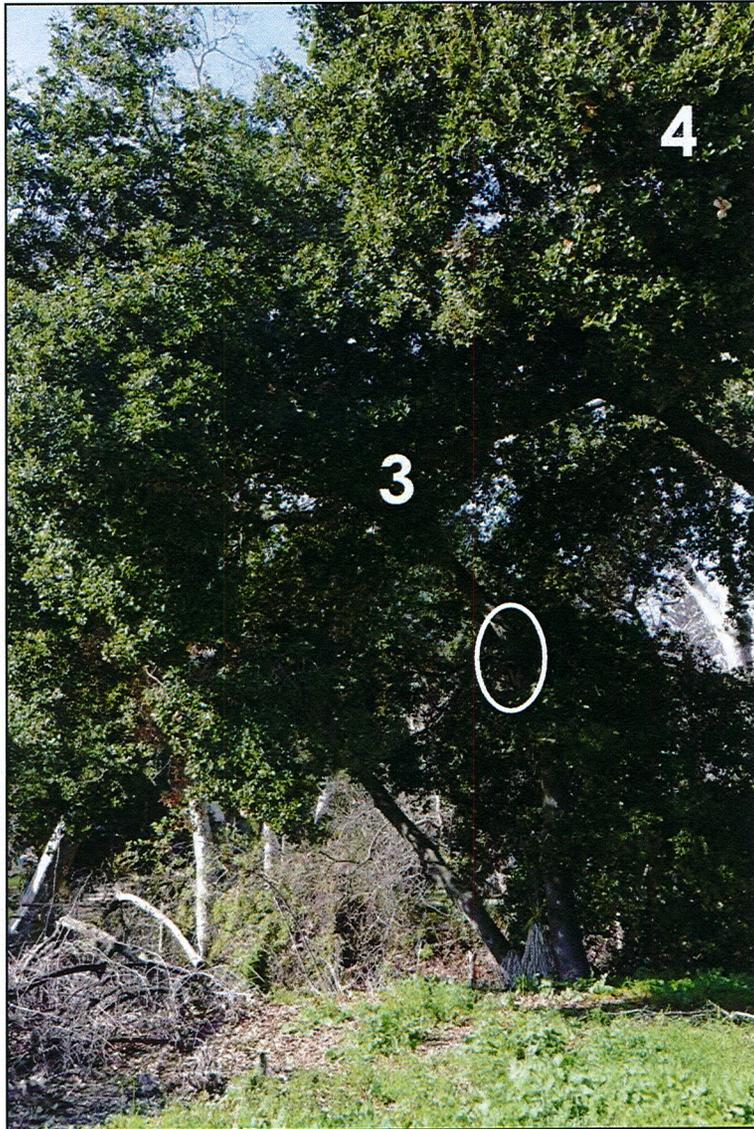
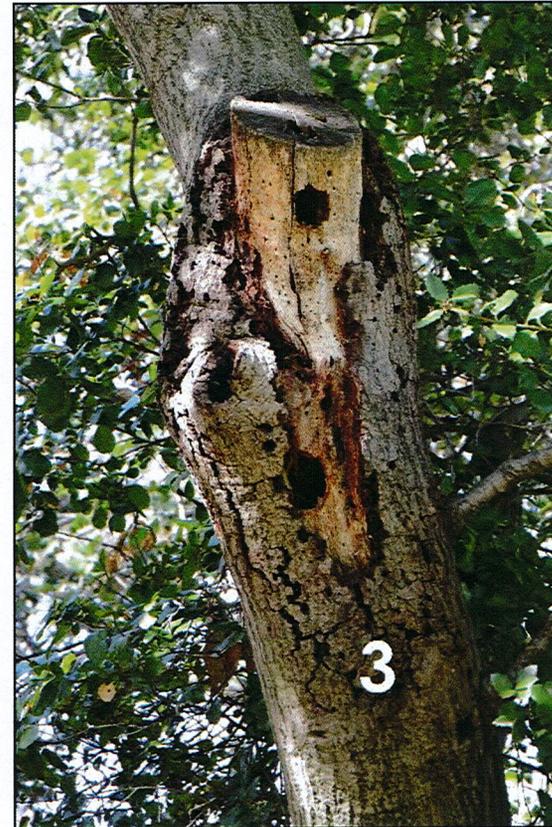
**Coast live oak #3** and the problem with the decay in one of its two trunks, the trunk leaning over the project site. The left photo shows the decayed area circled. The right photo shows a close-up of the decay. There is a lot of internal decay here, because there is a bird nest inside. The weight of the canopy is above this decayed portion.

2. **Tree Removals:** Three trees, **#11, 12 and 13 coast live oak** will need to be removed because they are within the proposed entrance roadway into the site. I also recommend removal of one trunk of the multi-trunk **coast live oak #3** that is overhanging the site, because it has significant decay and is likely to fail over the site.

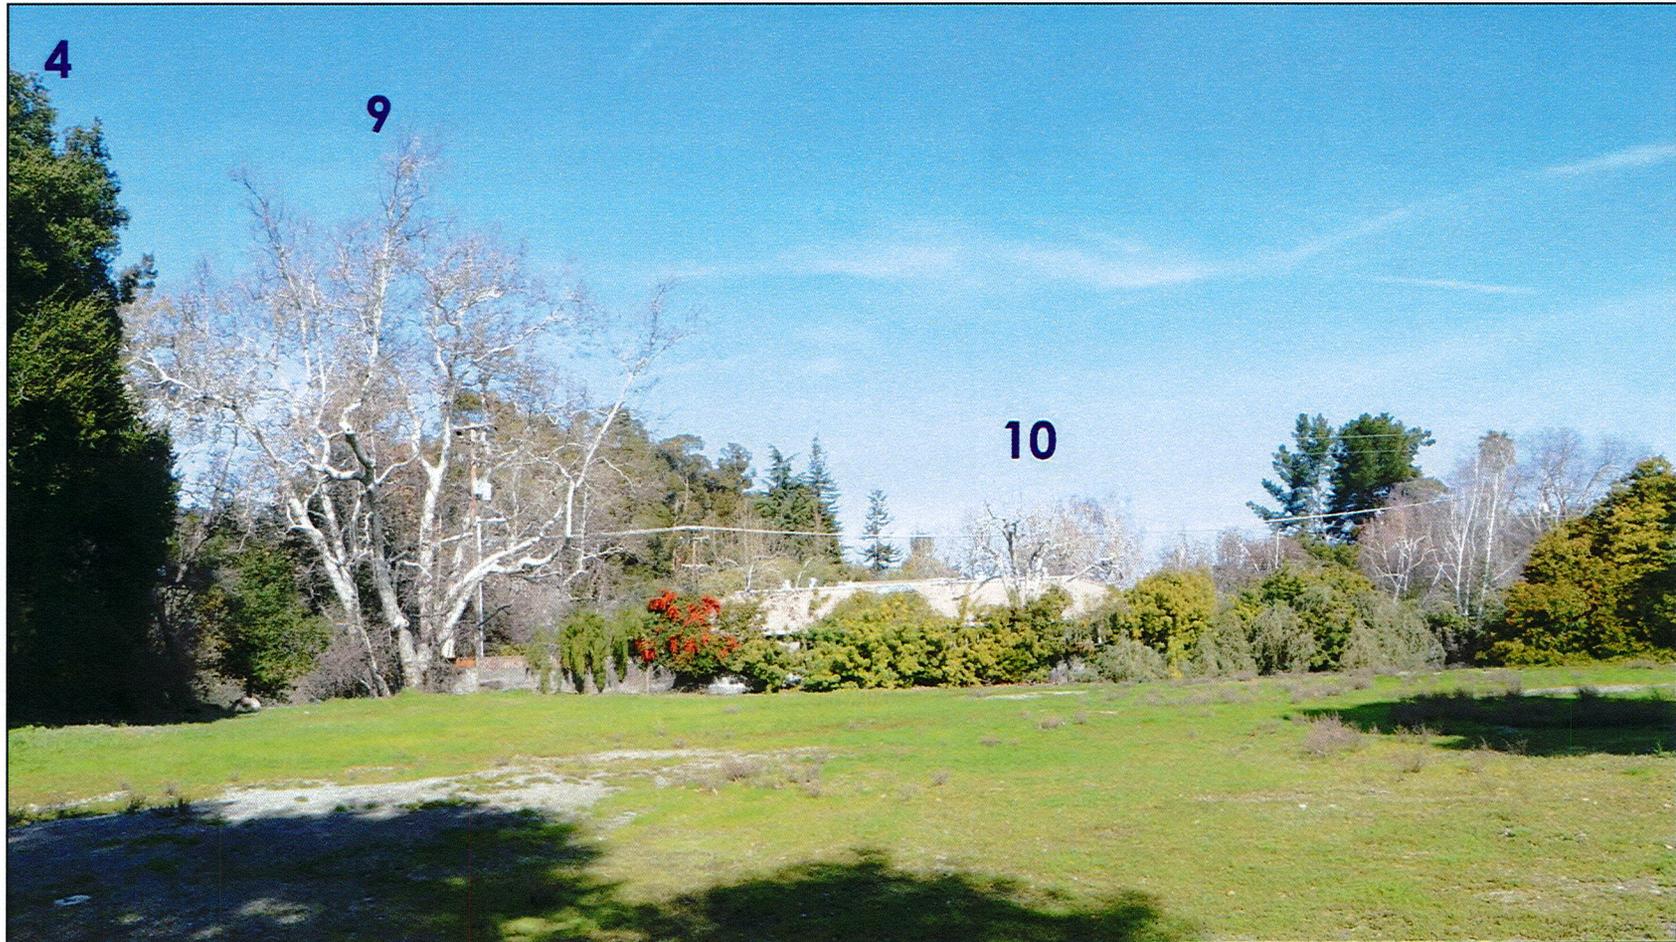
North perimeter of the site, Lot 1. Left to right: the edge of large **coast live oak #4**, **California sycamore #9** and **London plane #10**.

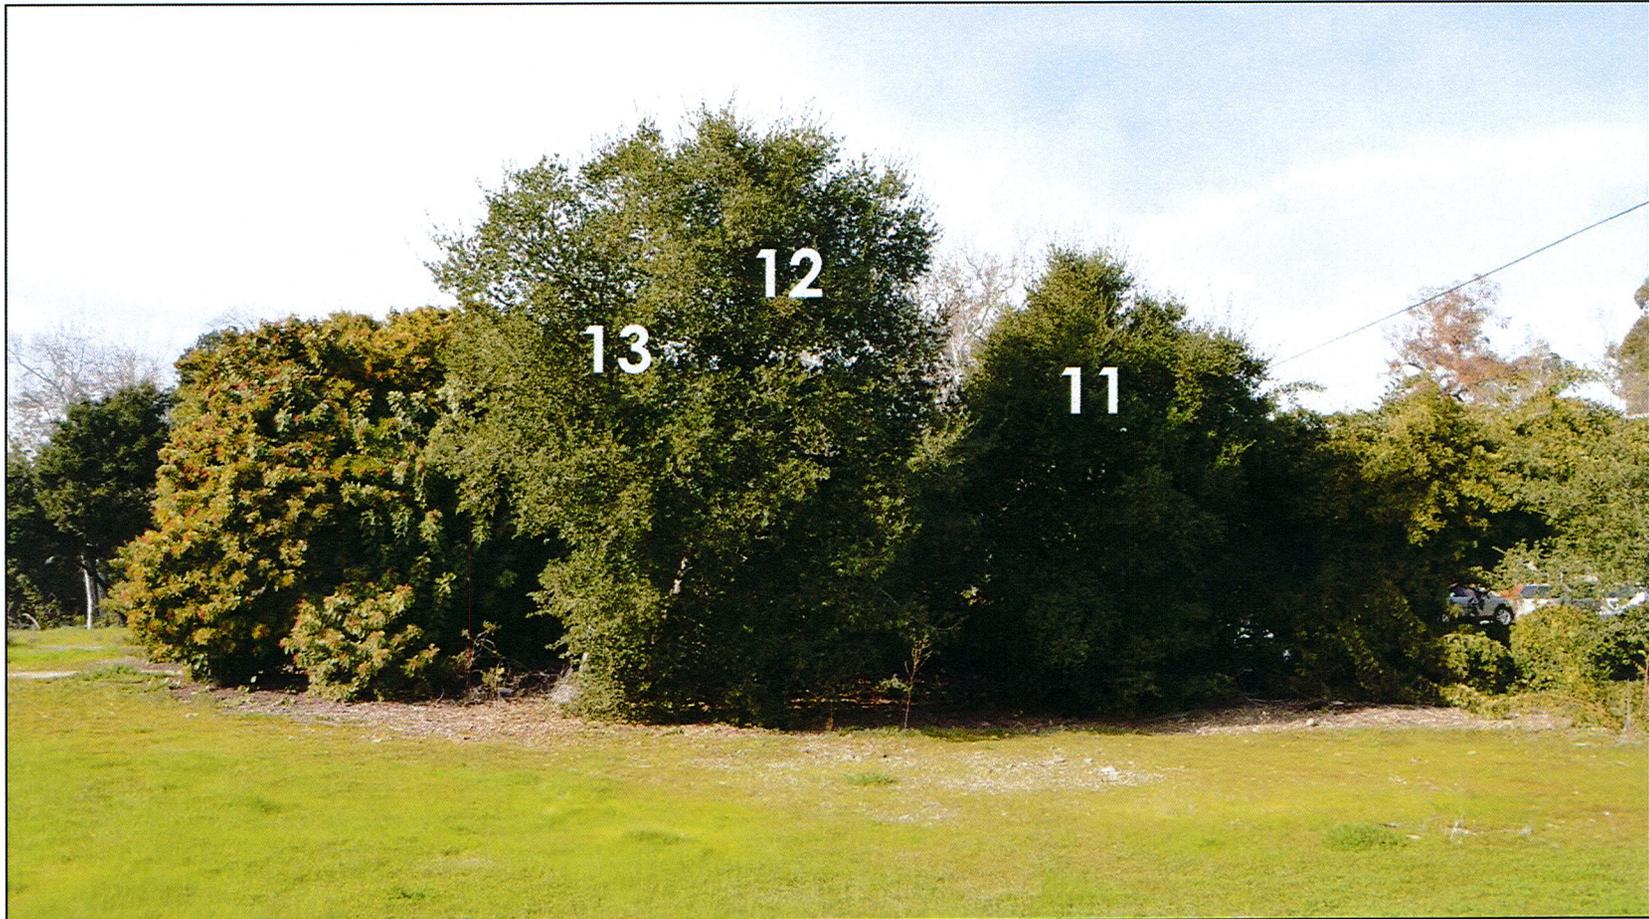
The west perimeter of Lot #2, viewed from the west. **Coast live oaks #11, 12 and 13.** All three of these trees will be removed because they will be within the extension of Saratoga Creek Drive.

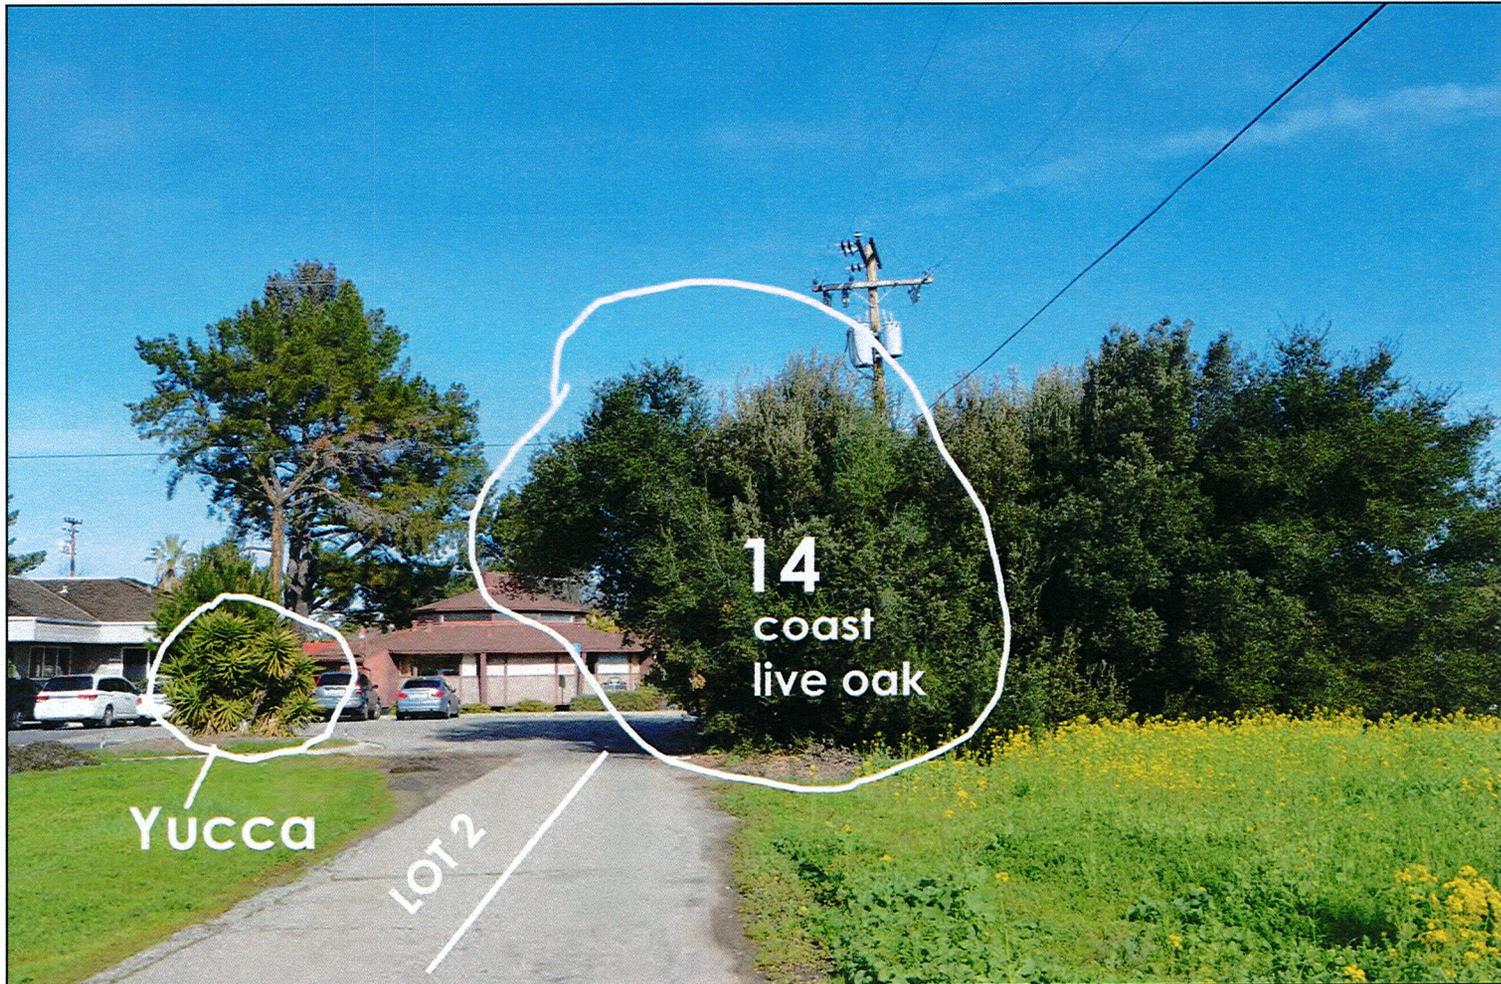
The northeast corner of Lot 2. **Coast live oak #14** overhangs the site slightly

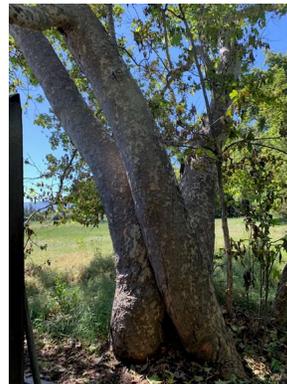
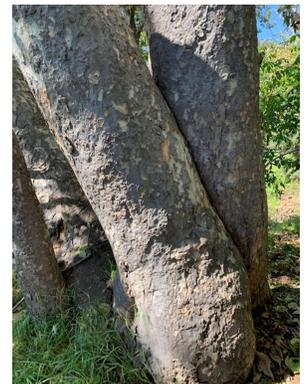
Tree #9 (*Platanus racemose*) has trunk three co-dominant trunks at the base. The trunk diameters were measured at 54” above grade. The trunk diameters are 20”, 21.5” and 27” (see images to right).

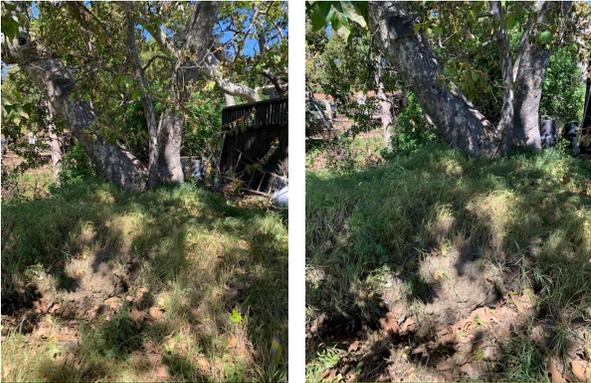
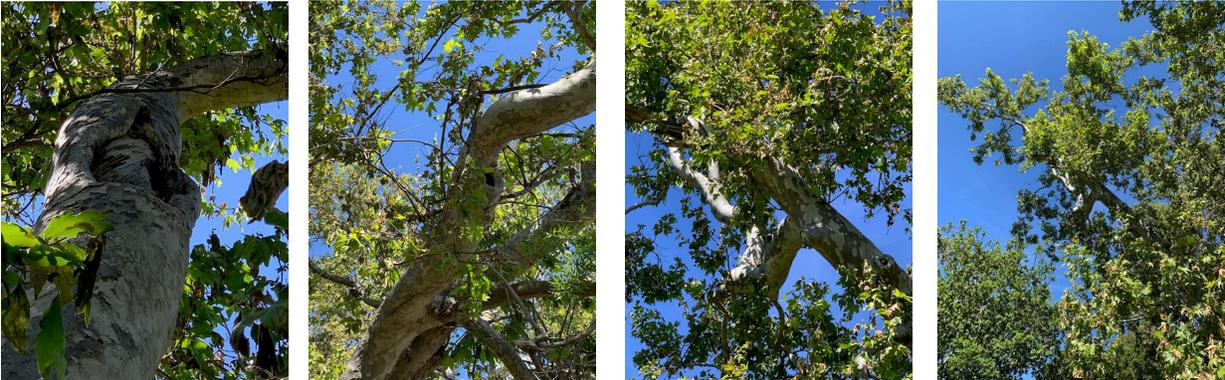
Tree Health is Fair. Tree Structure is Fair – Poor due to the codominant main trunks, which are prone to failures. This tree has also torn large limbs in the past and now has large decay spots in the main trunks. These assessments are based upon the Table below:

Native Sycamore trees are not the most stable of trees. They tend to lean and grow long until

they break limbs. This tree is no exception (see images above). Due to the tree species, the severe lean and the fact the tree is phototropic leaning for the sun, it has lost large limbs and now there are significant decay spots in the main trunks. This compromises the structural stability of the tree in general. This tree is currently in need of corrective pruning (to ISA Standards) to help prevent future limb failures.

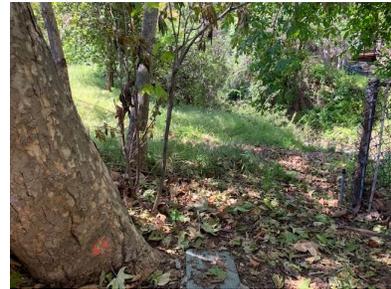
Additionally, there is 22’ of land between Tree #9 and the edge of the creek, before it drops off (see image to right).

There is therefore a total undisturbed diameter area of 43.6’ around this tree.

It is my opinion that the proposed development will not negatively impact Tree #9 and should proceed with as planned with the following Tree Protection Measures:
