Page 1 of 4 *Resource Name or # (Assigned by recorder): Congregational Church Parsonage
P1. Other identifier: HP-88-01

State of California - The Resources Agency
DEPARTMENT OF PARKS AND RECREATION
BUILDING, STRUCTURE, AND OBJECT RECORD

Resource Name (Assigned by recorder) Congregational Church Parsonage

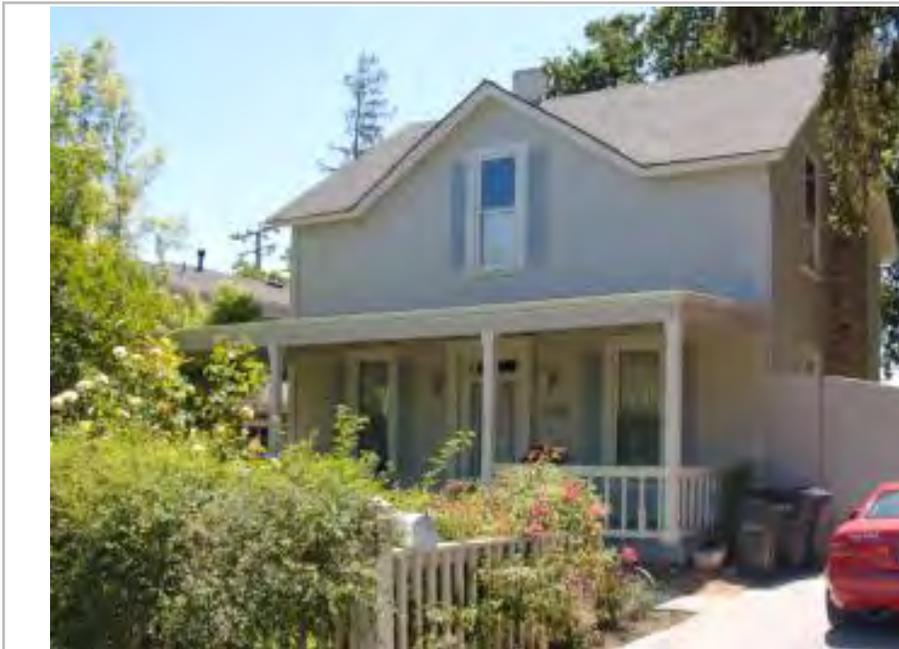
Typical of a National (Pioneer) design, this symmetrical one-and-one-half-story house has distinctive balloon-framed proportions, primarily visible in the raised eaves of the cross-gabled roof, the narrow roof span and relatively steep roof pitch, as well as the raised floor. The house is side-gabled with an accent gable centered in the front elevation. One double-hung window is centered in this front gable at the upper floor of the front facade. At the first floor, individually placed double-hung windows flank the centered front door. The door features a 2-lite transom. The channel-rustic siding and flat-board trim is consistent with the era; uncommon is the narrow board-and-batten siding in the side gable end. The full-width front porch may be an original design, with simple wood posts and low banister. The house may have been relocated to this property, as the first floor height would commonly have been raised on a pony wall. The window sash has been replaced.

P5b. Description of Photo:
(View, date, accession #)
View facing east, July 2009.

Although altered with replacement window sash, the house retains adequate character-defining architectural design, workmanship and materials, as well as a historic location and setting within Saratoga Village, and the property continues to represent the historical associations and feelings of this residence.
