FIELD ASSESSMENT REPORT AND RECOMMENDATIONS

Based on Koi Pond Life Support Systems Site Visit – April 29, 2015

Project Name: Hakone Gardens	Site Location: Saratoga, California	Date: 6/30/2015
---------------------------------	--	--------------------

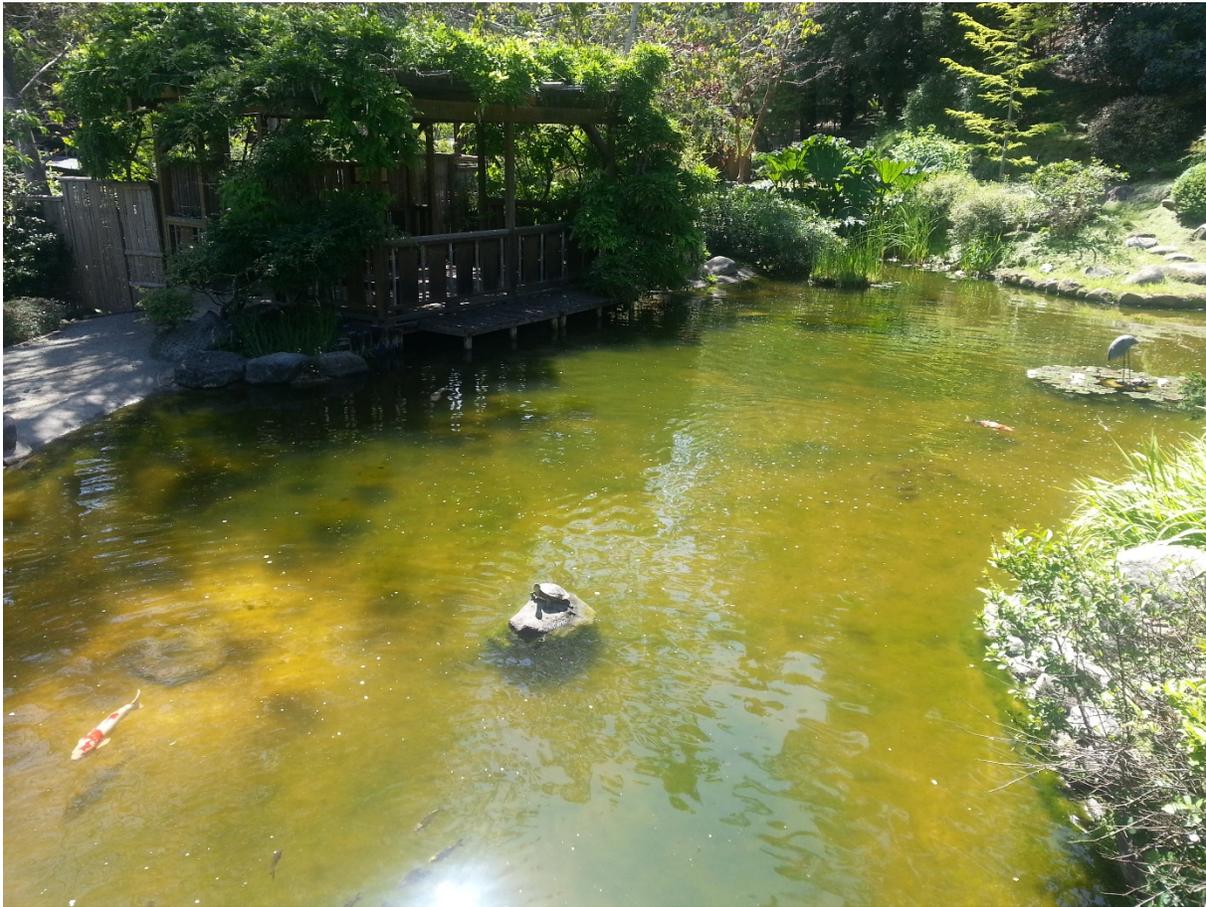
Based on discussions with staff Jacob Kellner, Gardner for Hakone Gardens, we have developed a flow schematic, which illustrates the current system. (See Figure I)

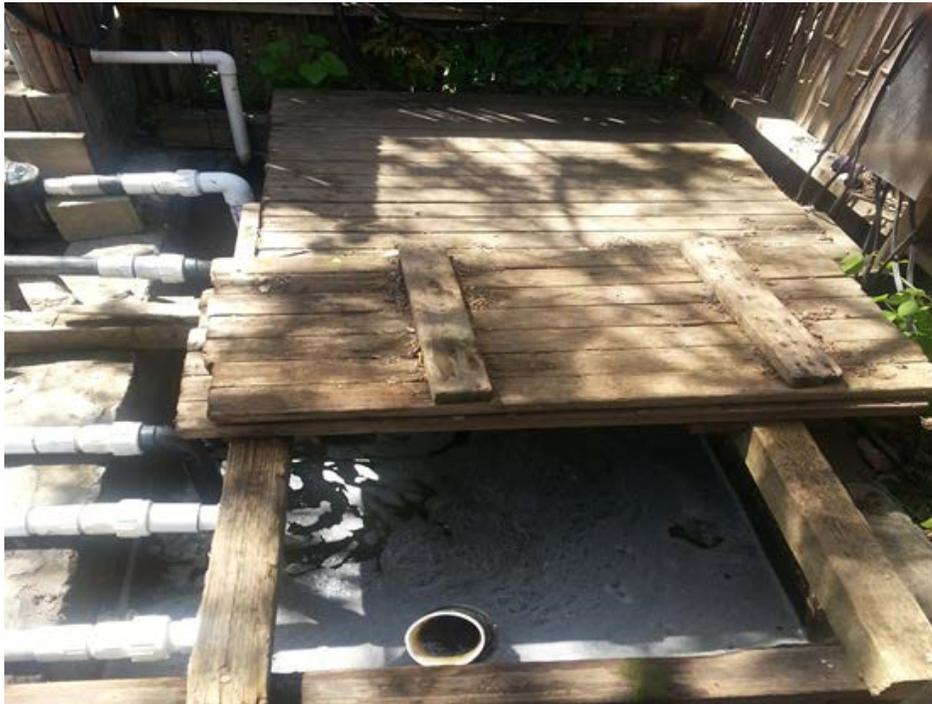
Water currently leaves the pond through a single pipe outlet located in one corner of the pond and gravity flows to a return sump. This return sump is 95-inches x 45-inches and approximately 12 feet deep (18.5 gallons/inch). The sump is cleaned yearly (4 hours/year).

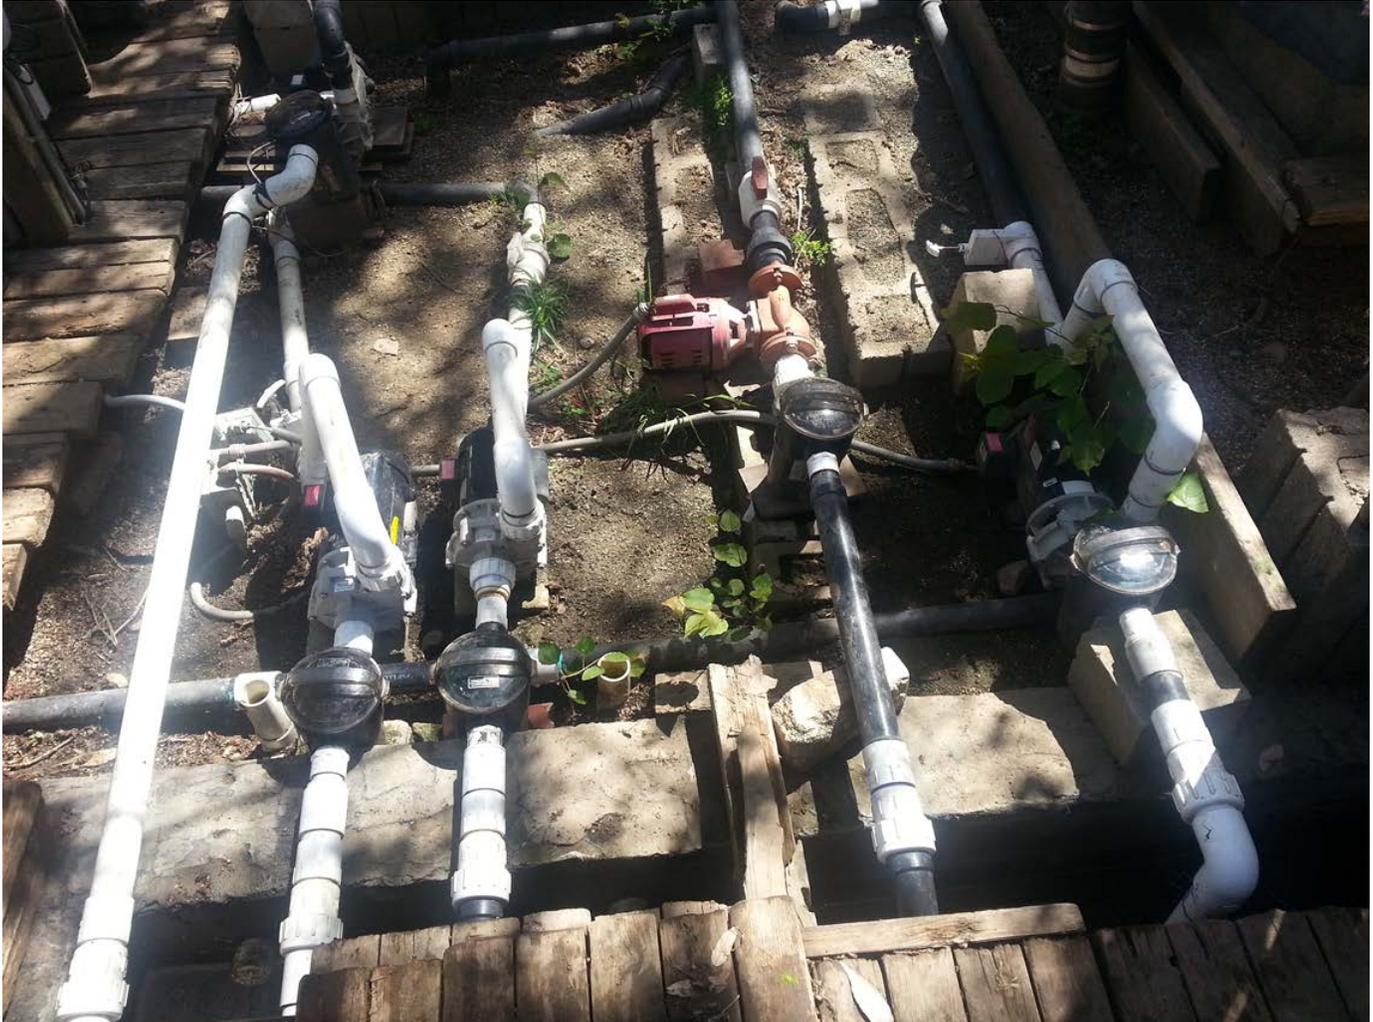
Water is drawn out of the sump with five small fractional horsepower pumps (1/4HP/pump, 2-inch line, measured flow approximately 27gpm/each by timing the drop in the sump level with the pond outlet blocked).

- a. Double the Flow through the Pond. Increase the flow rate through the pond by doubling the flow through the gravity gravel filters. We believe the filters can handle twice the flow they are currently operating. This would require a redesign of the pumps, sizing the system and validating the pipe sizes. Hopefully this can be done without significant piping changes. If the Hakone Gardens wants to accomplish this without major engineering costs we could probably increase individual pumps one-at-a-time until the piping sizes are maxed out. PCA would be willing to work with the staff to accomplish this. Now as the flow increases, the gravel filters will probably need to be cleaned more frequently, but that is the purpose, to get more solids out of the system at a more rapid rate. This will require more operator time.

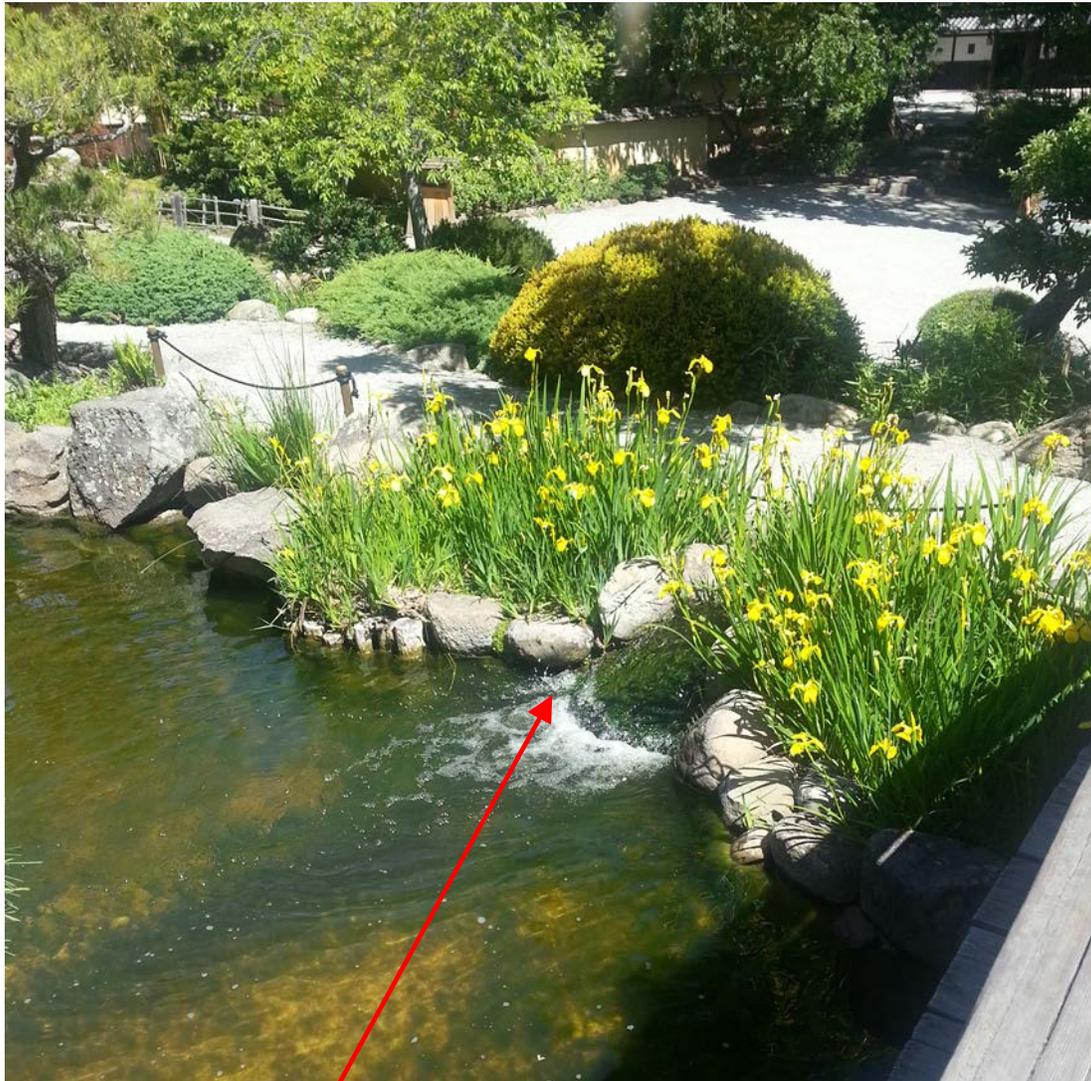
Pond Inlet Flow

Water flows by gravity from the gravity gravel filters back to the pond through a single inlet.

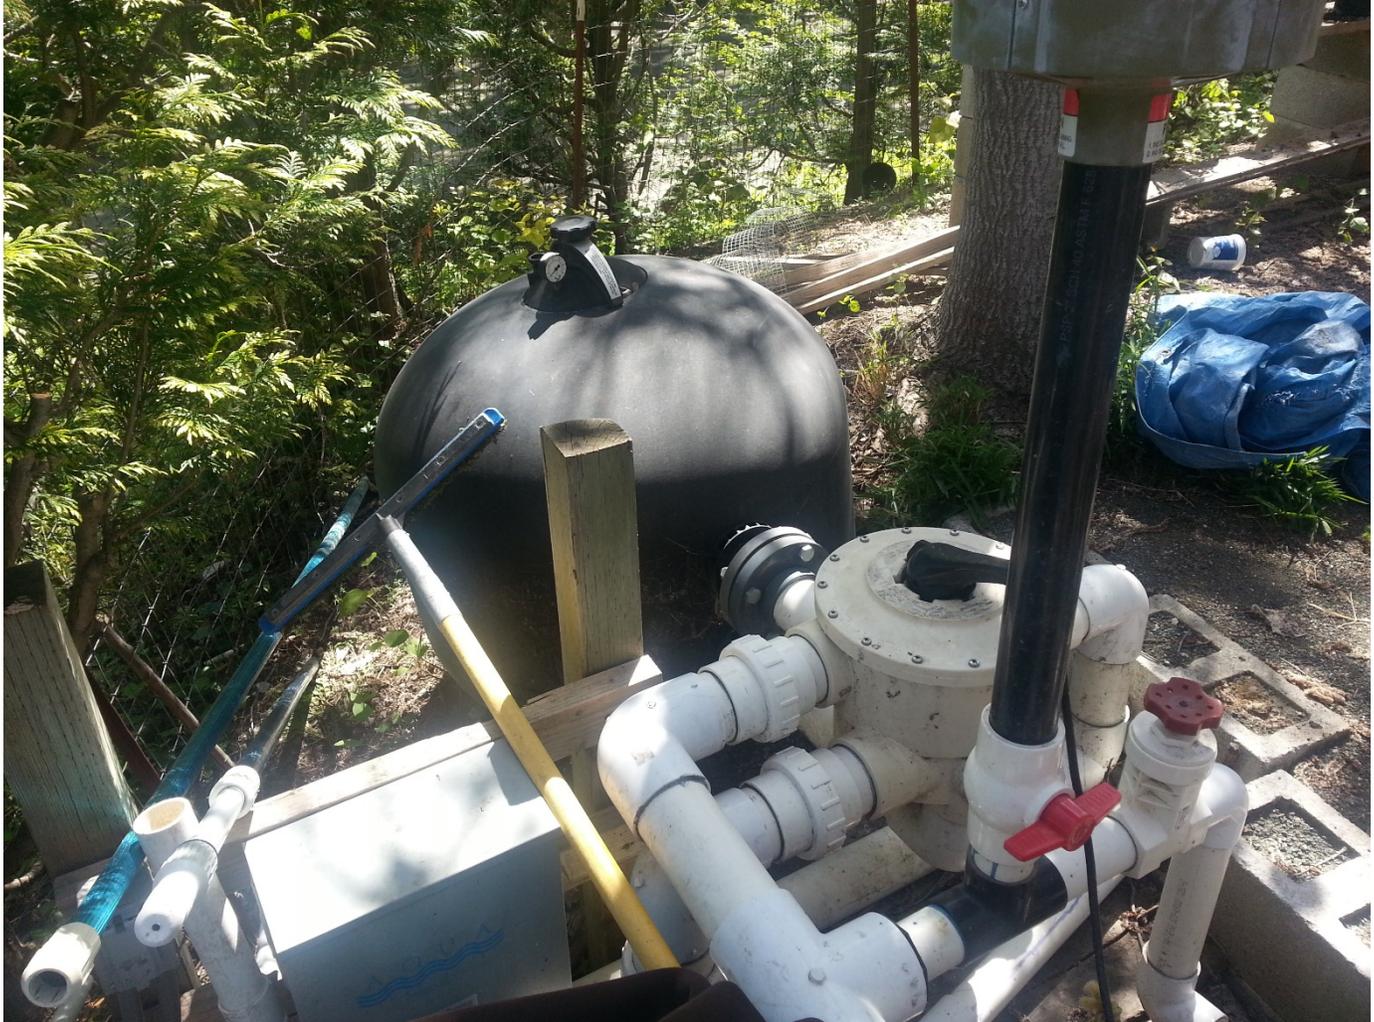
One of the recirculating pumps flow from the return sump to a single 36-inch pressure filter. The pressure filter is backwashed once or twice a week to the storm drain. The blower is operated to assist backwashing.

- b. Re-operate the pressure sand filter/UV system. The system is probably not really adding any benefit to the pond water quality. We would recommend checking the filter media (size, quality), rebuilding the filter, if necessary, remove the pump suction from the sump and connecting it to the gravel filter discharge, increase the flow (doubling it), increase the size of the UV unit and develop a budget and preventative maintenance on the UV bulb replacement, develop a method of correctly backwashing this filter by either installing a separate backwash pump that connects to the gravel filter discharge and wastes to a storage tank (this water can be used for irrigation) or try and utilize the waterfall pump to double duty as the filter backwash pump. Validation of using the waterfall pump would require some investigation into the actual size of this pump and the hydraulics to and from the pump location to the pressure filter site. The cost of a new pump vs. using the waterfall pump would need to be compared.

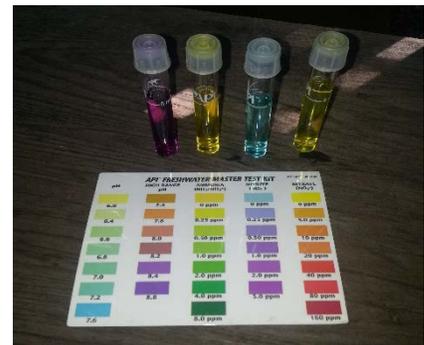
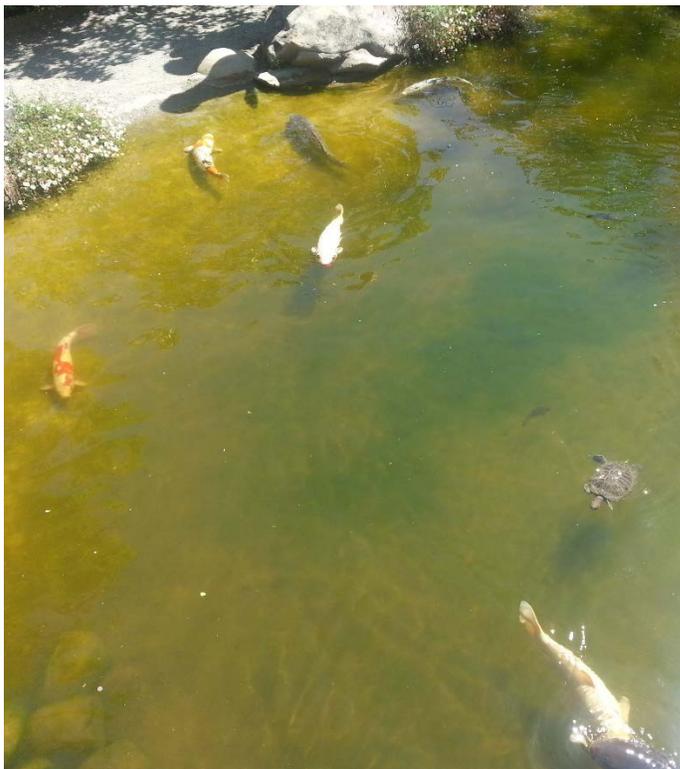
pH, ammonia, nitrite and nitrate were measured and showed:

1. pH above 8.8 (exceeded to range of the test)
2. Ammonia, nitrite and nitrate were all reading near zero. Note: it is highly unlikely that the nitrate is zero in this system.

- e. Monitor temperature, ammonia and nitrate. We believe the nitrate test is not measuring correctly. Either the test kit needs to be upgraded or samples should be sent out to an outside lab. It would be nice to know the nitrate level. In addition, it would be nice to measure total bacteria in the pond. This could be sent out to an outside lab.

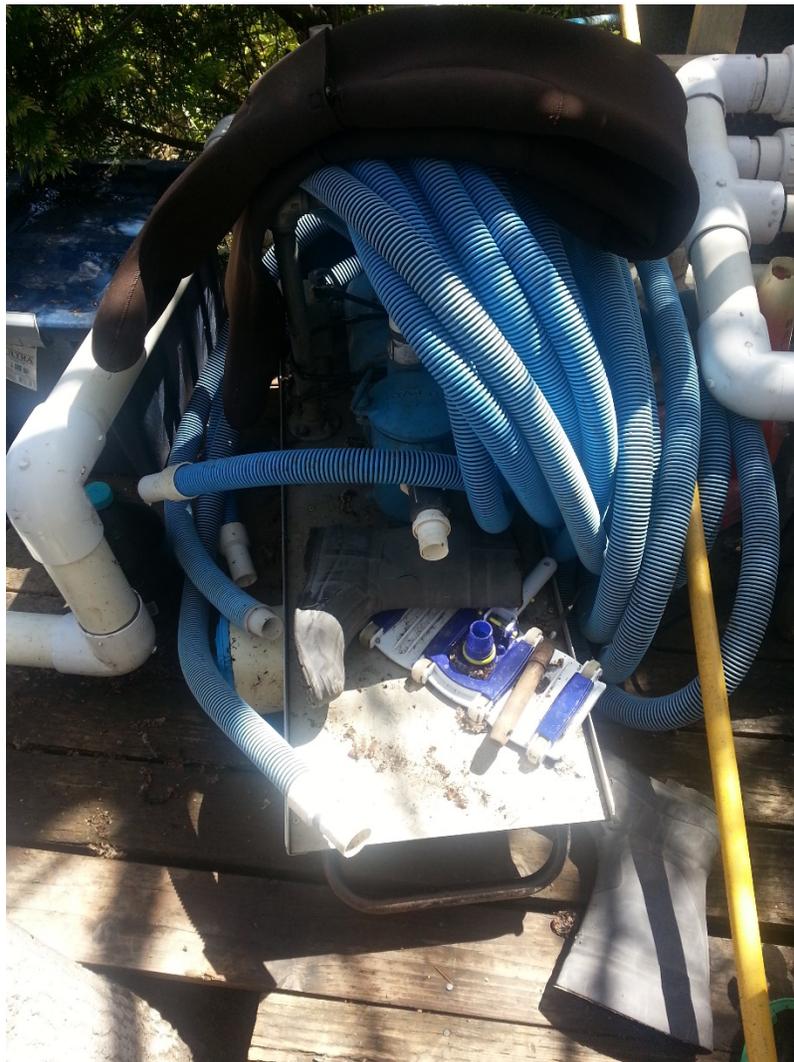
The system currently has a portable vacuum system that consists of a pump with attached strainer and bag filter. This system doesn't work because the bag filter clogs quickly. This needs to be replaced with a diaphragm pump and hose that can discharge into the gravity filters.

- c. Get a rigorous vacuuming in place. The staff has an improved vacuuming pump on order. The existing pump is inadequate. A new positive displacement (preferably a diaphragm pump) needs to be used and the vacuuming procedure needs to be developed and rigidly provided until the water system can be improved.

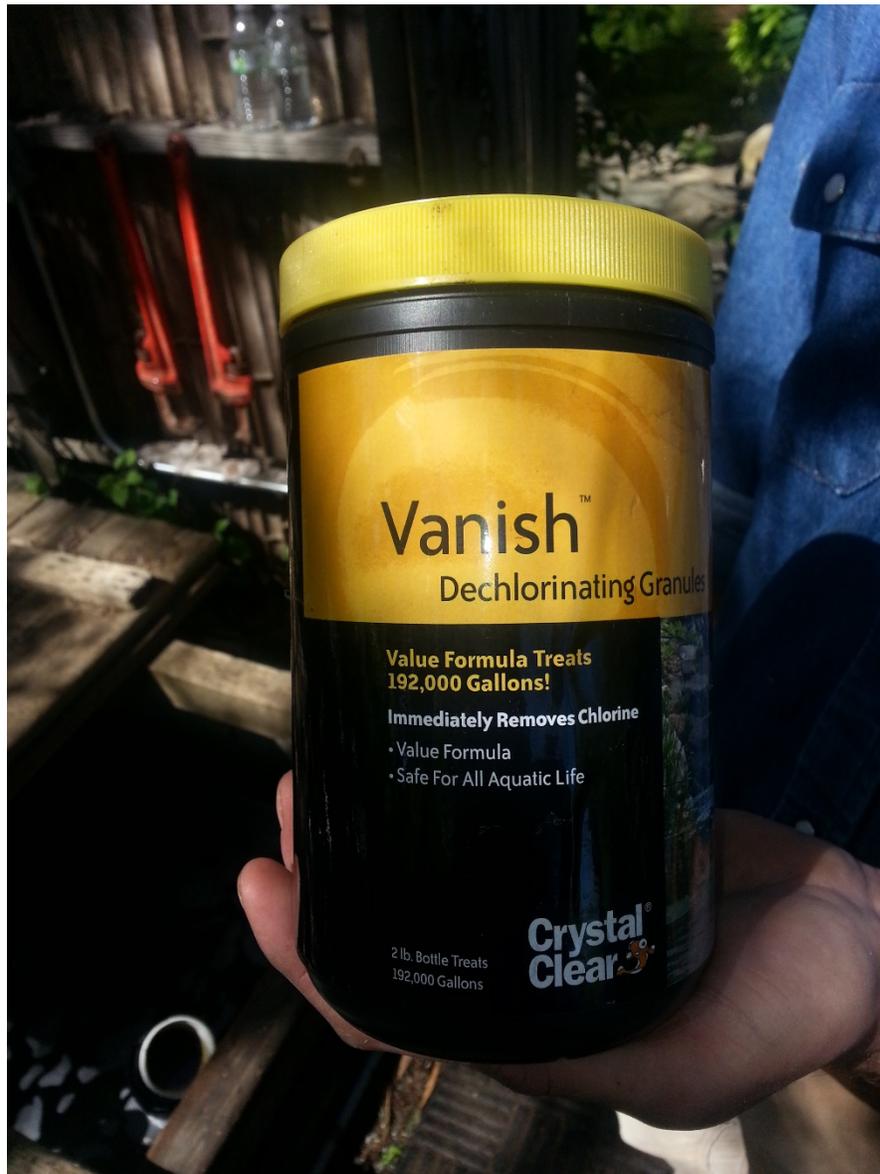
The operators currently are using Crystal Clear for dechlorination of the potable water when water is added. Crystal Clear is a sodium thiosulphate based material and is therefore a reducing agent. The procedure for adding this material needs to be reviewed and adjusted.

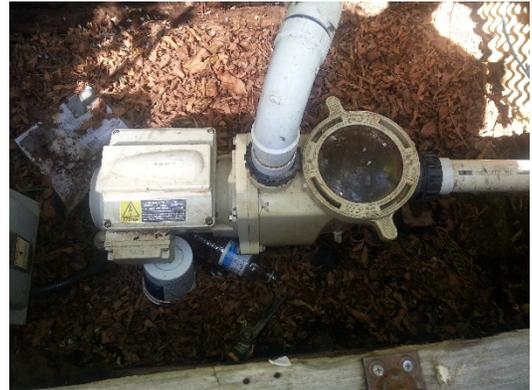
The waterfall is important to the operation of the pond. It provides for circulation and aeration. The system consists of a 3HP pump which is variable speed. The pump was indicating a flow of 130gpm. This wasn't verified. Flow out of waterfall seems closer to 250gpm. The piping is designed to allow for a smaller side river located adjacent to the water fall. It is currently not working because of leakage.
