*Arborist Report for Palm Villas Saratoga Project:  
January 29, 2016*

## ARBORIST REPORT

Tree Inventory, Tree Descriptions and Recommendations Relative to Proposed Construction

### Palm Villas, Saratoga (Lots 1 & 2)

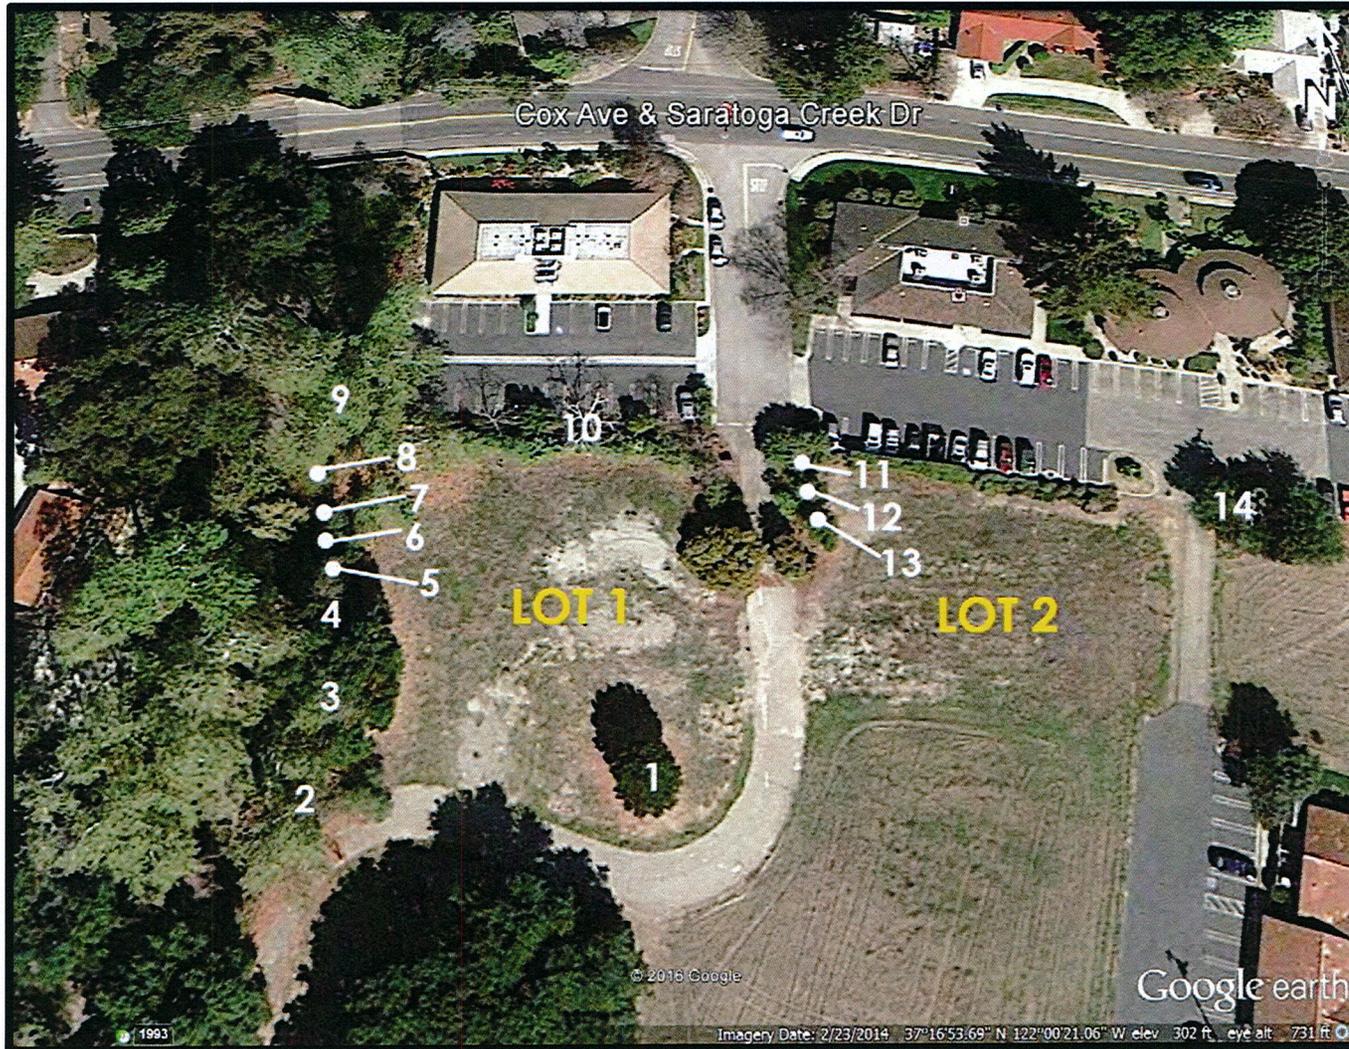
# TREE MAP #1

There are 14 **protected trees**<sup>1</sup> with driplines that may be within 5 feet of proposed construction. Most of these trees are on neighboring properties adjacent to the project site. Only 4 of the trees (**#1, 11, 12 and 13**) are located on the project site. Three trees (**coast live oaks #11, 12 and 13**) will need to be removed because they are located within the proposed extension of Saratoga Creek Drive. These are small trees that have trunk diameters of 7 to 8 inches. **Coast live oak #3** has a large decayed area on one of its two trunks that overhang the site. The trunk overhanging the site should be removed. It should be possible to save all of the other trees although I have recommended a few design modifications to reduce damage for **coast live oak #1** and **California sycamore #9**.

2. **Tree Removals:** Three trees, **#11, 12 and 13 coast live oak** will need to be removed because they are within the proposed entrance roadway into the site. I also recommend removal of one trunk of the multi-trunk **coast live oak #3** that is overhanging the site, because it has significant decay and is likely to fail over the site.

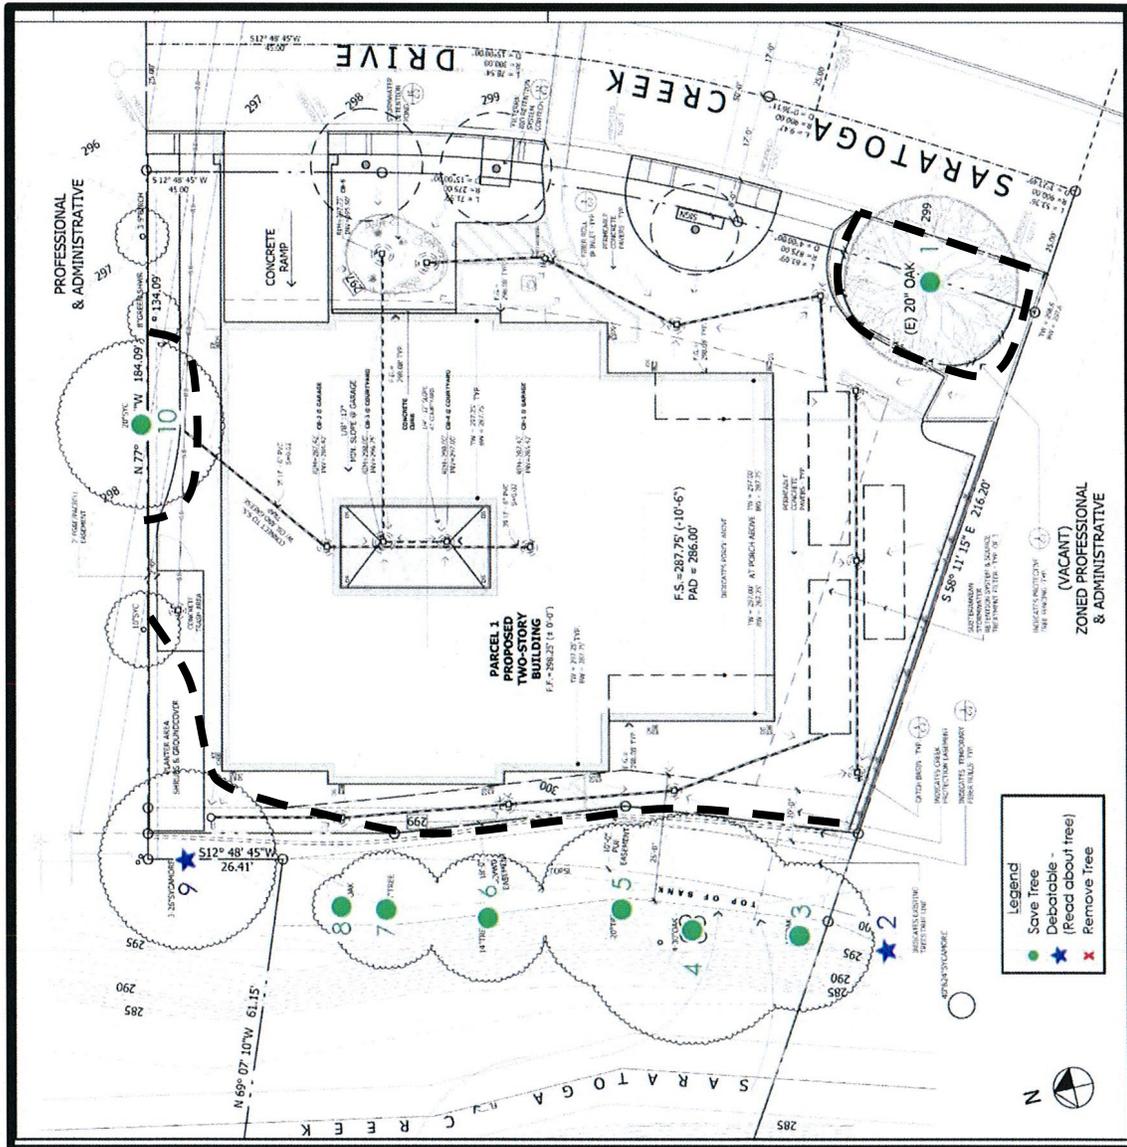
# TREE MAP #2 - LOT 1

**Elderberry #3**<sup>2?</sup> is not shown on any of the construction plans I received, but is located between a 40 and 24-inch sycamore on adjacent property to the south, and coast live oak #3 on the Topographic Survey, near the southwest corner of Lot 1. This is a sprawling multi-trunk tree that has split apart and fallen over, with most of its trunks dead. A portion of the tree is still alive (an 8 to 10-inch trunk) and the tree may overhang (or be lying on) the project site. I recommend that the trunks of the tree, be they living or dead, be cut to short stumps about 6 inches tall. The shrub/tree will probably regrow from these stumps and provide value for wildlife and erosion control above the creek.

3. **Design changes are recommended around coast live oak #3 and California sycamore #9** to reduce construction damage. Please read about this in the *Notes* column of the Complete Tree Table.

4. **Elderberry #3:** this tree is not shown on any of the construction plans I received, but is it located between a 40 and 24-inch sycamore and coast live oak #3 on the Topographic survey, near the southwest corner of Lot 1. This is a sprawling multi-trunk tree that has split apart and fallen over, with most of its trunks dead. A portion of the tree is still alive (an 8 to 10-inch trunk) and the tree may overhang (or be lying on) the project site. I recommend that the trunks of the tree, be they living or dead, be cut to short stumps about 6 inches tall. The shrub/tree will probably regrow from these stumps and provide value for wildlife and erosion control above the creek.

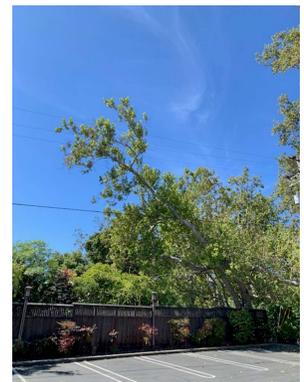
This tree has a disproportionate shape. The tallest point is 45’ tall, but the majority of the tree is closer to 30’ tall. The tree leans to the East heavily. It leans 45’ Est and only 10’ to the West.

Tree Health is Fair. Tree Structure is Fair – Poor due to the codominant main trunks, which are prone to failures. This tree has also torn large limbs in the past and now has large decay spots in the main trunks. These assessments are based upon the Table below:

The proposed foundation for the new construction is 21.6' from the outside of tree trunk for tree #9 (see attached diagram). This is an acceptable distance for development from this tree and does not pose a significant threat to the health or stability of the tree. The developer dug an exploratory trench, at the request of the City Arborist, Kate Bear, to demonstrate that no significant roots would be impacted on this compression side of the tree (see images to right – trench was dug a while ago and is somewhat obscured by new growth in these images). No roots were found in this exploratory trench at all.
