**SUBJECT: Addendum to Geotechnical Investigation (report) dated December 18, 2008**

**RE: Saratoga Corporation Yard Carport  
Saratoga, California**

**REFERENCE:** Cotton, Shires and Associates, Inc., Geotechnical Investigation report, Saratoga Corporation Yard Carport, Saratoga, California, dated December 18, 2011.

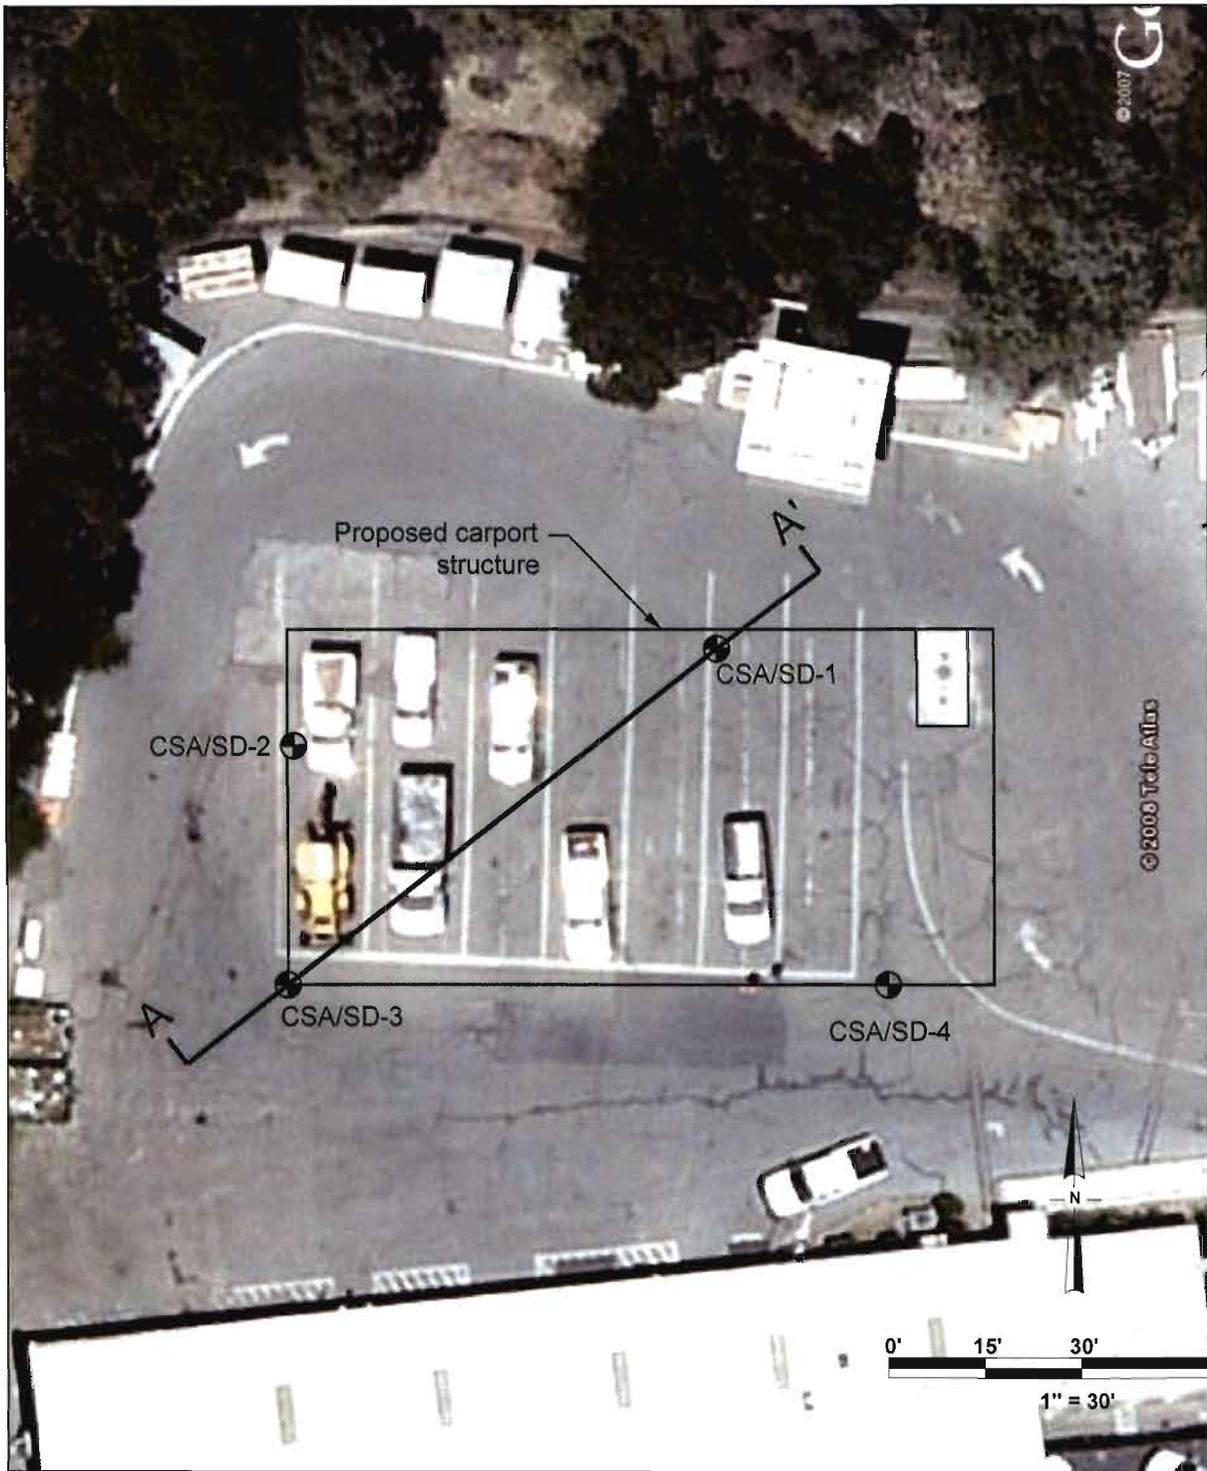
**EXPLANATION**

**SITE PLAN AND BORING LOCATION MAP**  
**SARATOGA CORPORATION YARD**  
**SARATOGA, CALIFORNIA**

We explored subsurface conditions on November 18, 2008 by means of four exploratory borings drilled to a depth of 13.5 to 26.5 feet at the location shown on Figure 3. In the boring, we generally encountered alluvial soil materials consisting of medium dense to very dense silty and clayey sands and gravels, medium stiff to very stiff clay, and large cobbles to the depths explored (see Figure 4). A detailed description of the exploration program, the log of the borings, and the results of the laboratory testing performed on representative samples are presented on the boring logs in Appendix A and in the laboratory test results of Appendix B.

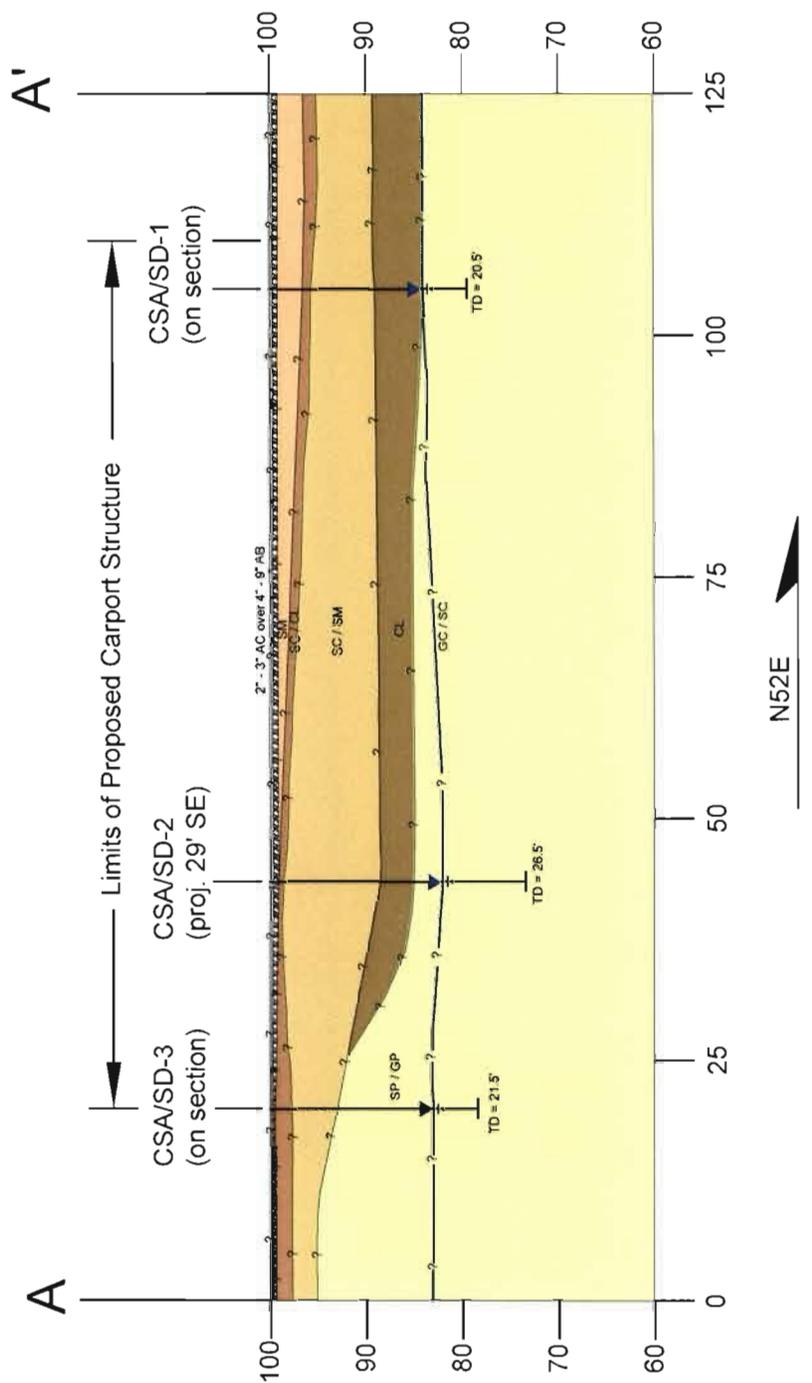
# EXPLANATION

- ALLUVIUM**
- BM** Silty Sand, gray brown to yellow brown, moist, medium dense to dense, some fine grained gravels
  - SC/SM** Clayey Sand / Sandy Clay, light brown to brown, moist, medium dense to dense / stiff
  - SC/SM** Clayey / Silty Sand with gravel, yellow brown to brown, moist, dense to very dense
  - CL** Silty Clay, olive gray mottled red brown, moist, stiff to very stiff, some gravels and sand
  - SP/GP** Gravelly Sand / Sandy Gravel, yellow brown to brown, moist, medium dense to very dense, some sandstone cobbles
  - GC/SC** Clayey Gravel / Clayey Sand, yellow brown to brown with gray clay, moist to wet, dense

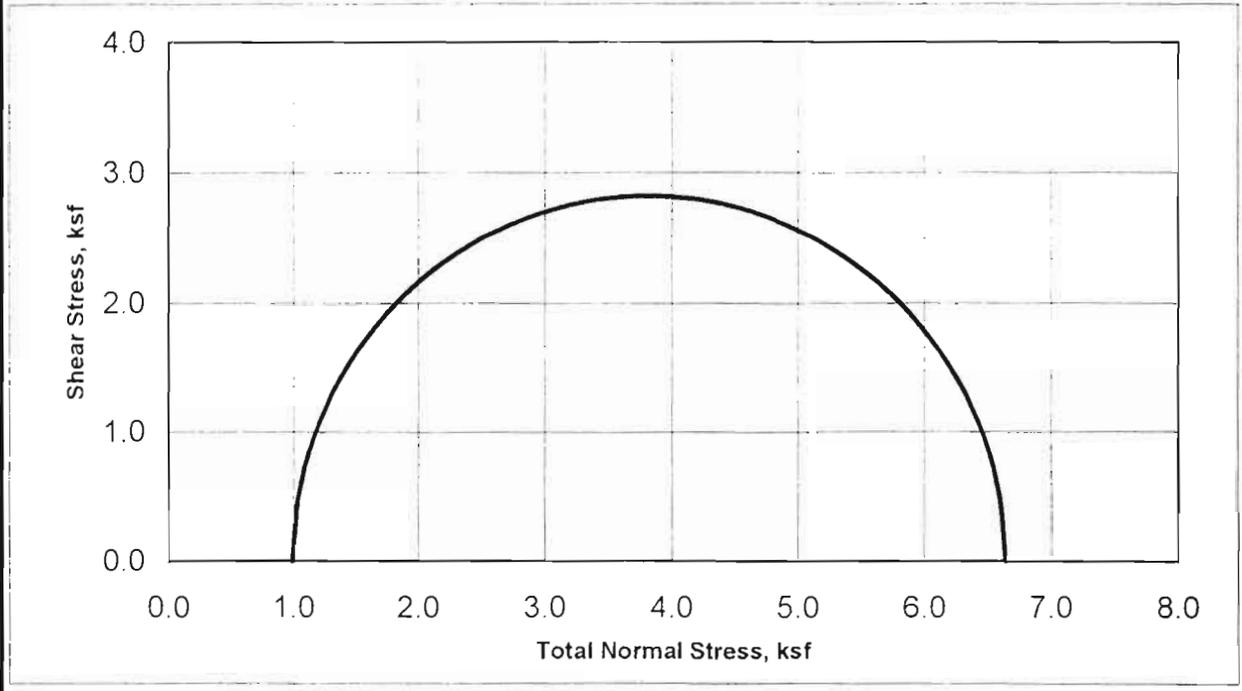
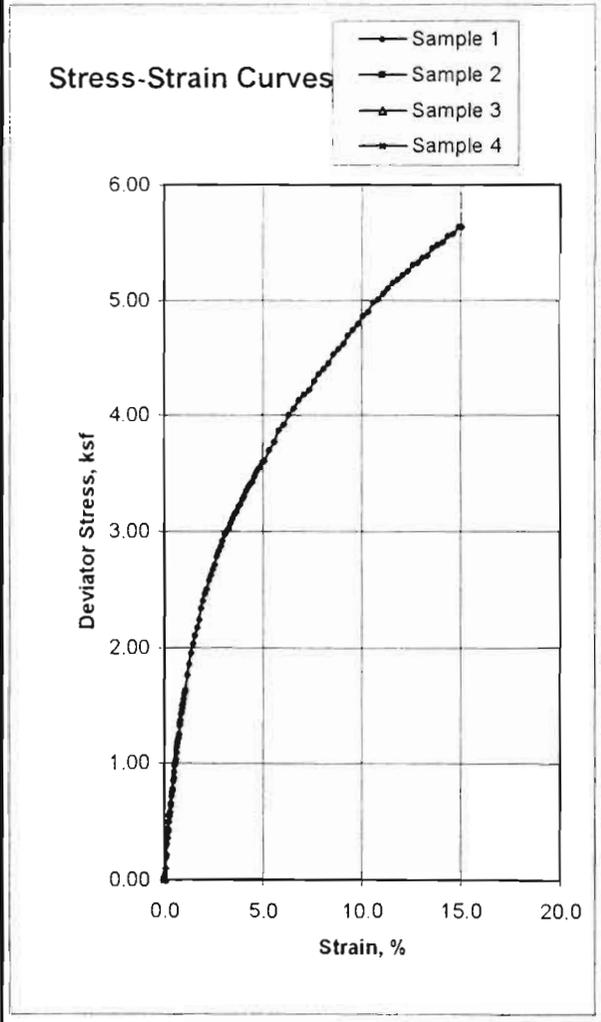
**Unconsolidated-Undrained Triaxial Test**  
ASTM D-2850

Sample Data				
	1	2	3	4
Moisture %	15.0			
Dry Den,pcf	115.1			
Void Ratio	0.465			
Saturation %	87.0			
Height in	5.00			
Diameter in	2.41			
Cell psi	6.9			
Strain %	14.90			
Deviator, ksf	5.640			
Rate %/min	1.00			
in/min	0.050			
Job No.:	026-415			
Client:	Cotton, Shires & Associates			
Project:	Saratoga Corp. Yard - E0328			
Boring:	SD-4			
Sample:	T-3			
Depth ft:	3.5			
Visual Soil Description				
Sample #	1 Brown Clayey SAND w/ Gravel			
	2			
	3			
	4			
Remarks:
